Osseo City Council Meeting

WORK SESSION

Attachments: KLM Engineering Report from June 2013
Emails from Council member Johnson
Conditions Assessment from Elk River

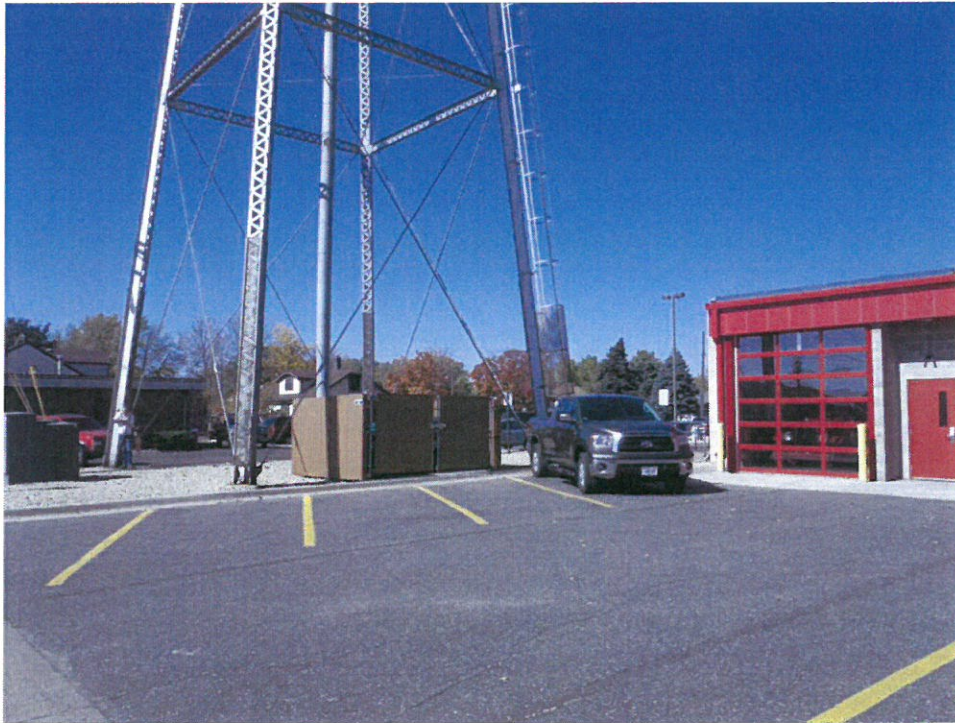
Photo No. 23

Typical exterior coating conditions – note antenna coax cable inside column

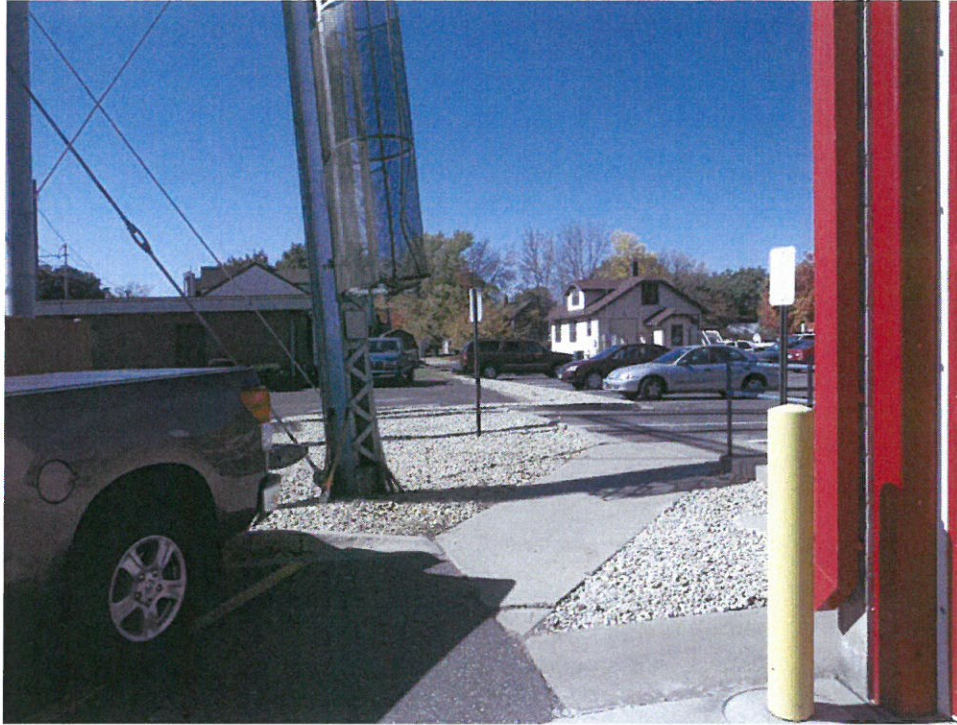
Photo No. 24

Conditions at base of tower

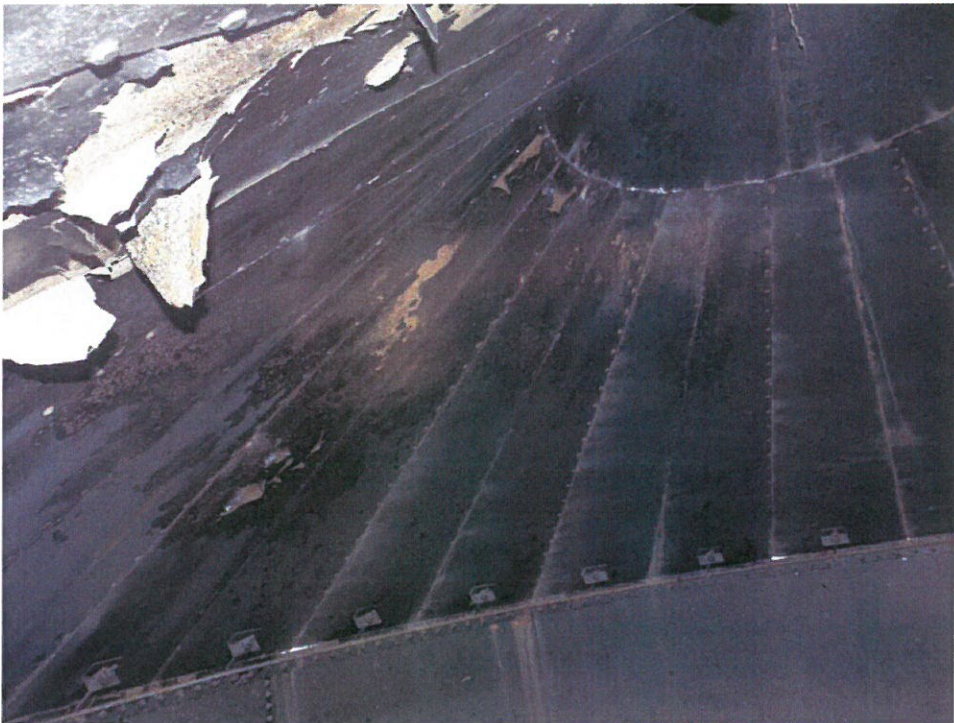
Photo No. 43
Typical conditions on roof – note delaminations

[The interior wet coating is in fair condition on the shell and bowl, and poor condition on the roof, which has large amounts of delaminating occurring, leaving bare steel with no corrosion protection. If the tower is to remain out of service, there is no immediate need to perform coating replacement, although if the tower is to be returned to service, the coating would need to be completely replaced. See photos in Appendix A.]

3.1.1 [The interior of the reservoir appeared to be in good overall condition, and did not exhibit large amounts of corrosion or pitting. See photos 43 through 50.]

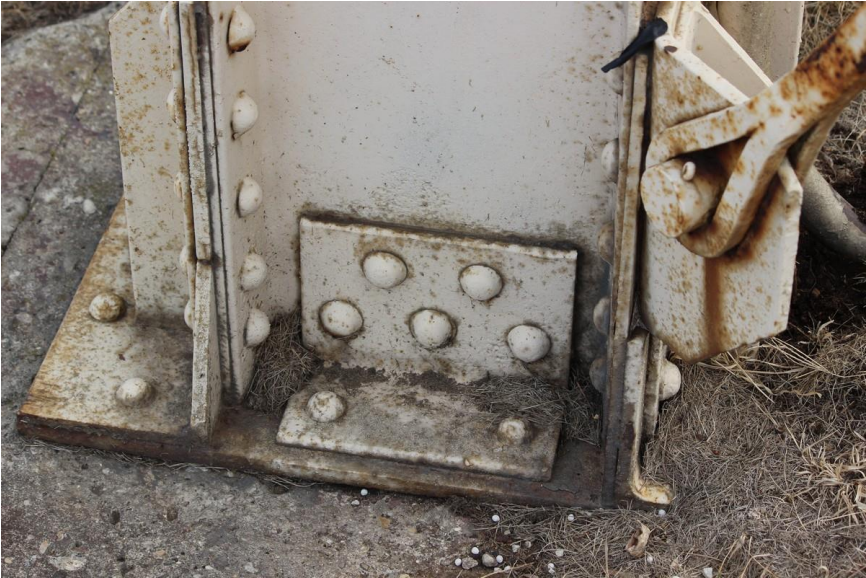
OBSERVATIONS	REFERENCE PHOTO
<p>4. The legs are connected onto a steel base plate at each footing with steel angles, all of which appear to be in average condition.</p>

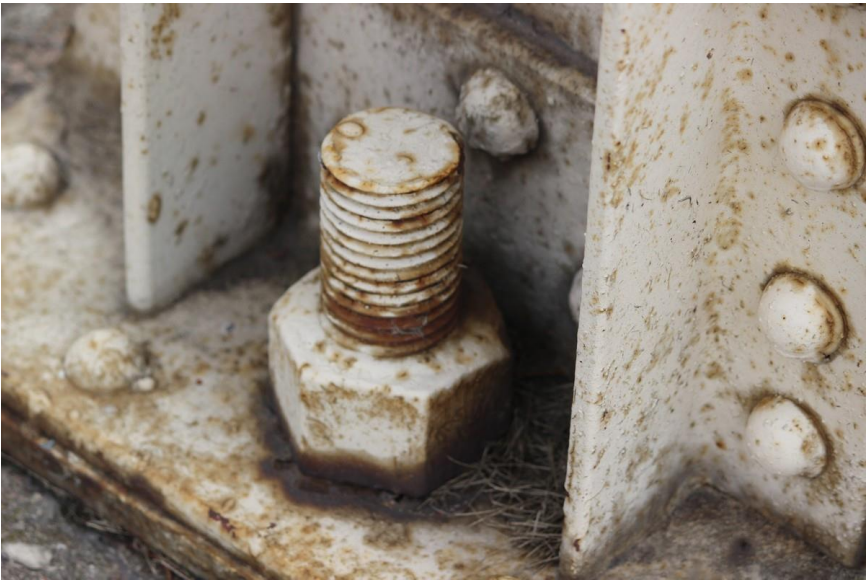
<p>5. The steel base plate at the bottom of each leg is bolted into the concrete footings. These bolts show no significant deterioration, and are in average condition.</p>

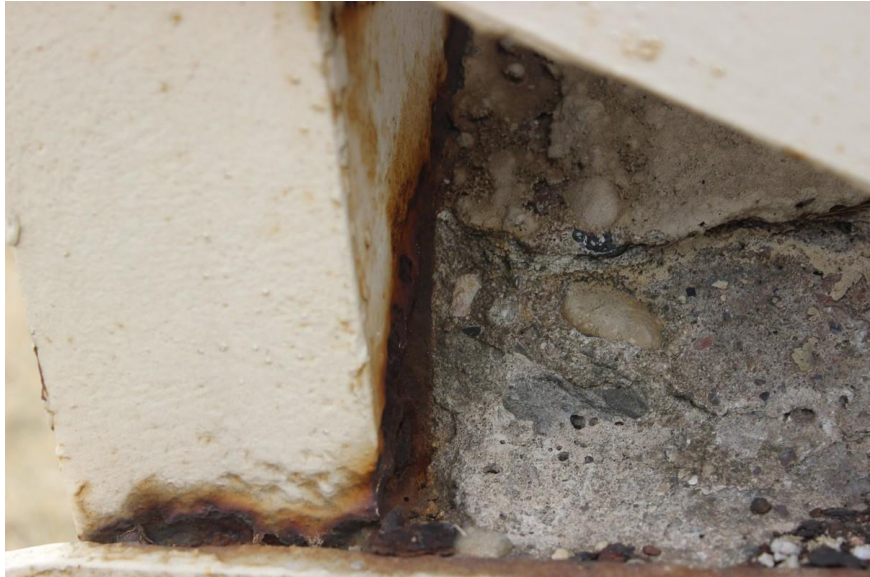
7. The sloped surface of the concrete allows water to drain from the base of the legs, but water that flows to sides of the legs has begun to rust and deteriorate the steel.

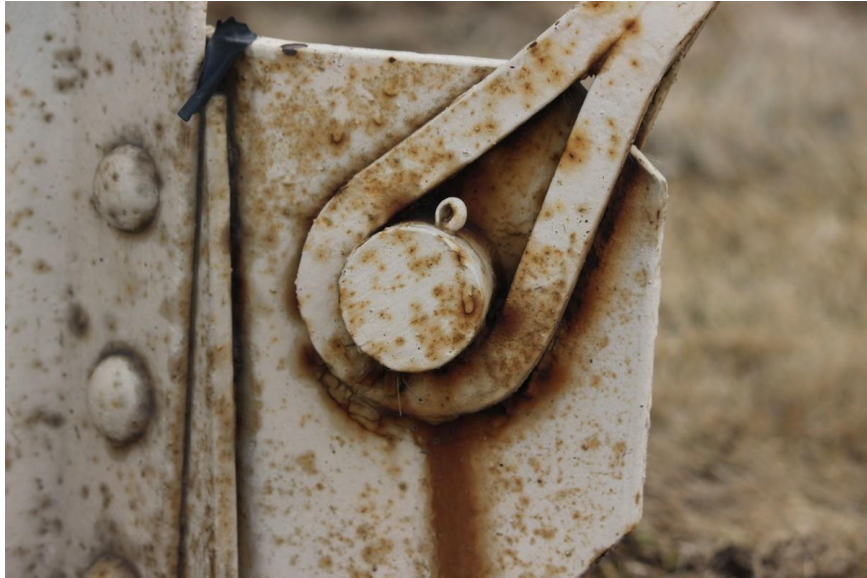
OBSERVATIONS	REFERENCE PHOTO
10. Steel tie rods are connected to the base of each leg. Steel legs and tie rods are covered with a significant amount of rust and chipped paint.

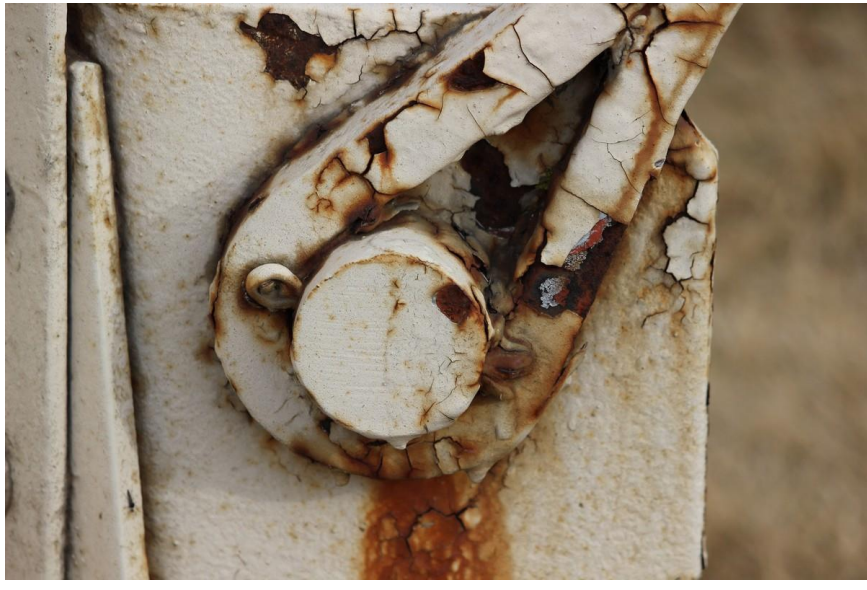
11. Rust and chipped paint are prevalent on all steel tie rods and legs.

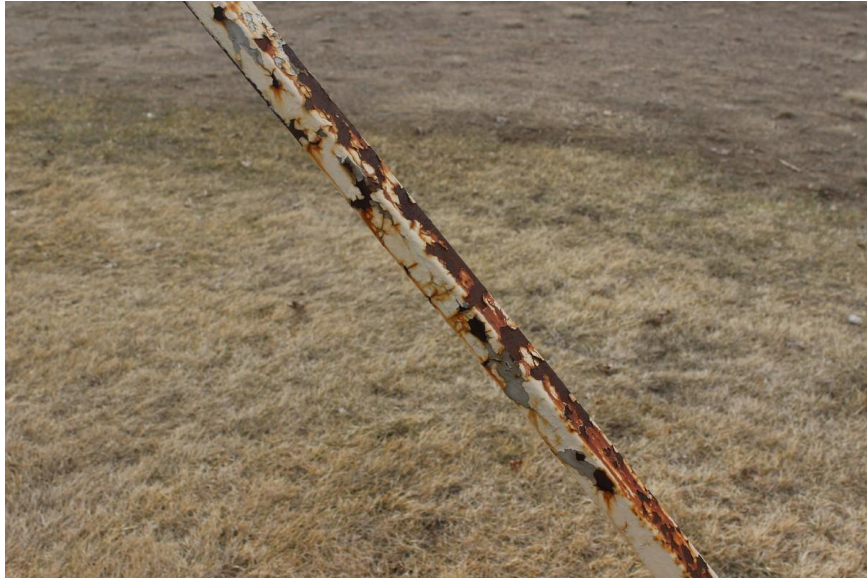
OBSERVATIONS	REFERENCE PHOTO
<p>12. Diagonal tie rods are in overall average condition and are performing well, but are showing a significant amount of chipped paint and rust.</p>

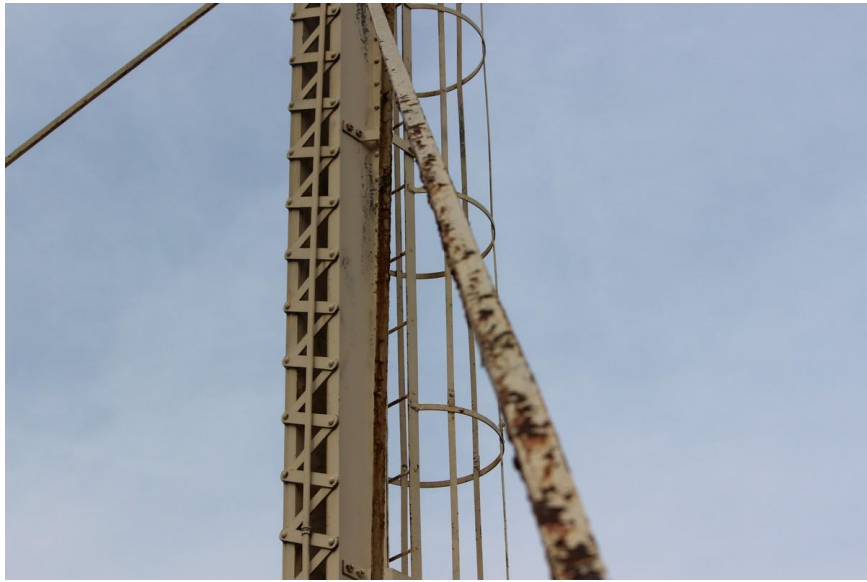
<p>13. Diagonal tie rods are in overall average condition and are performing well, but are showing a significant amount of chipped paint and rust.</p>

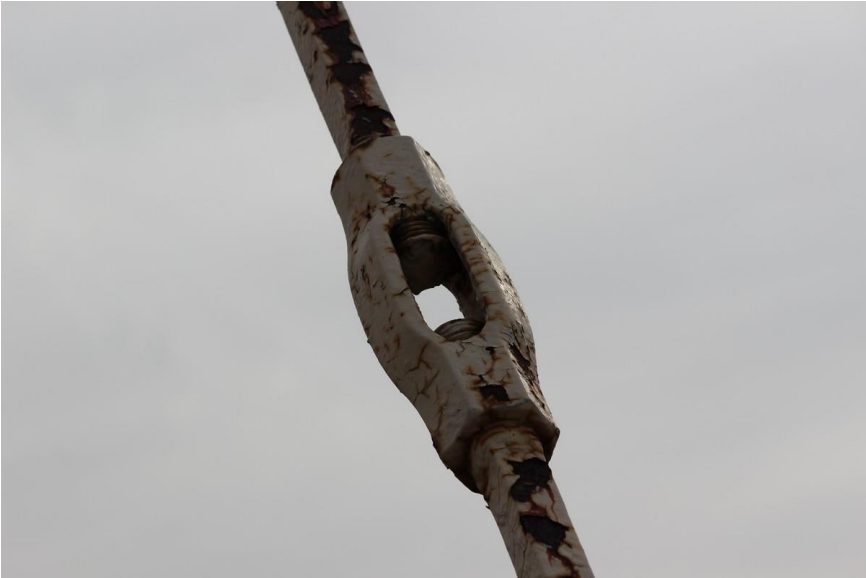
OBSERVATIONS	REFERENCE PHOTO
<p>14. Tie rods are connected with steel turnbuckles. Like the tie rods, these turnbuckles are covered with rust and chipping paint, but their performance is unaffected.</p>

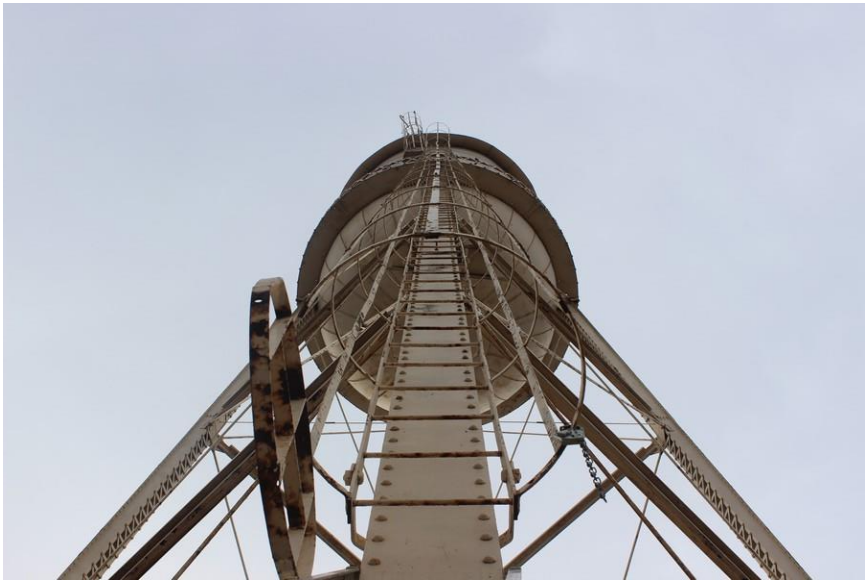
<p>15. A ladder extends up the northwest leg of the Water Tower. Surface rust and peeling paint are visible in some areas, but no functional concerns regarding the ladder were observed.</p>

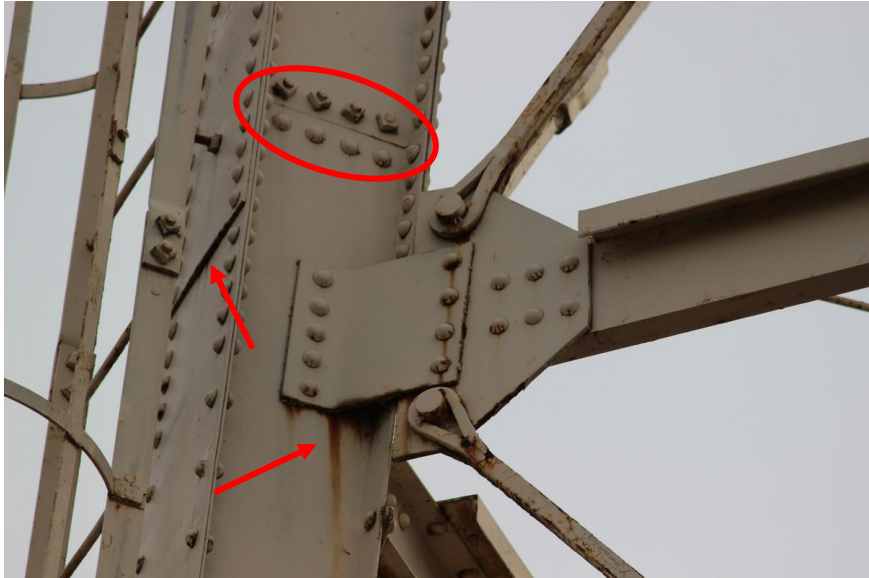
OBSERVATIONS	REFERENCE PHOTO
<p>20. The presence of bolts and rivets within the leg channels indicates that there is a steel plate inside the leg, the condition of which could not be ascertained from ground level. The steel bracket connecting the horizontal girder is rusting and the bottom of the exterior plate is expanding outward slightly.</p>

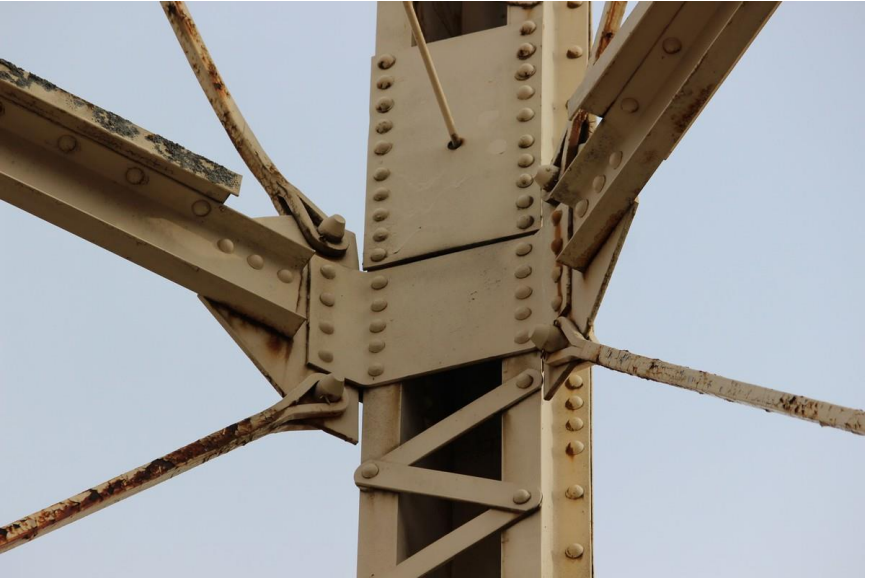
<p>21. A steel plate is attached to the legs just above the connection to the horizontal girders. Each of these plates (eight total) appear to be in average condition.</p>

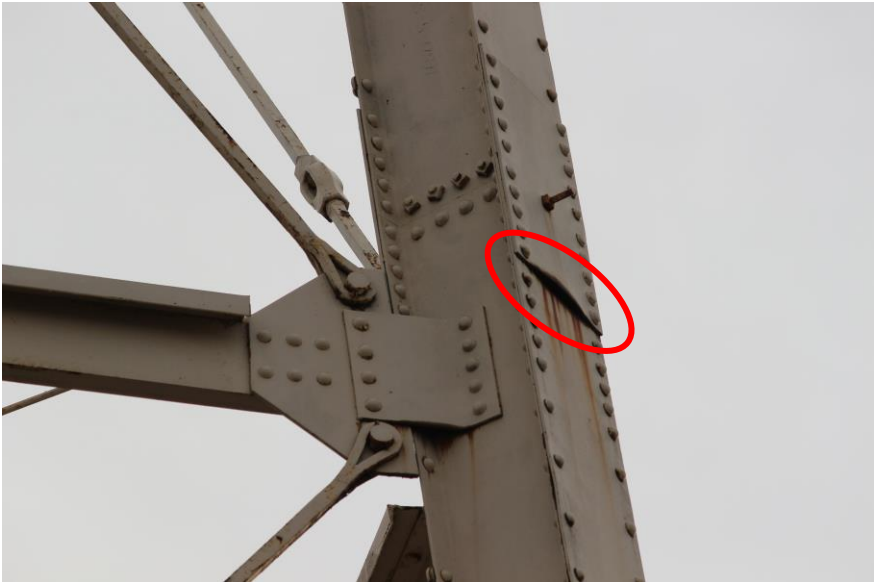
OBSERVATIONS	REFERENCE PHOTO
22. The plates on the outside of the Water Tower are in average to poor condition, with some showing significant rust and expansion.

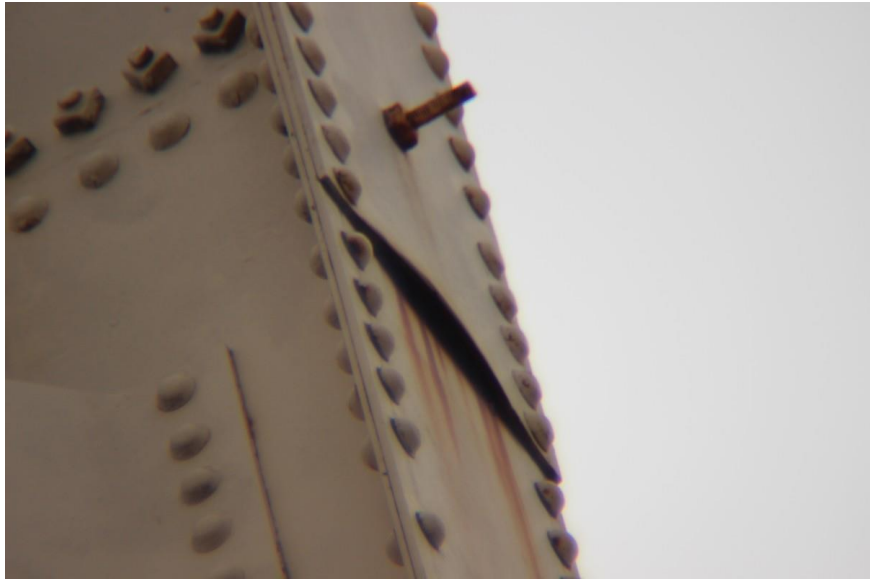
23. Close up of one of the outside steel plates. It appears as though water has corroded the backside of the plate, causing the steel to expand and bow outward, a condition known as rust jacking.

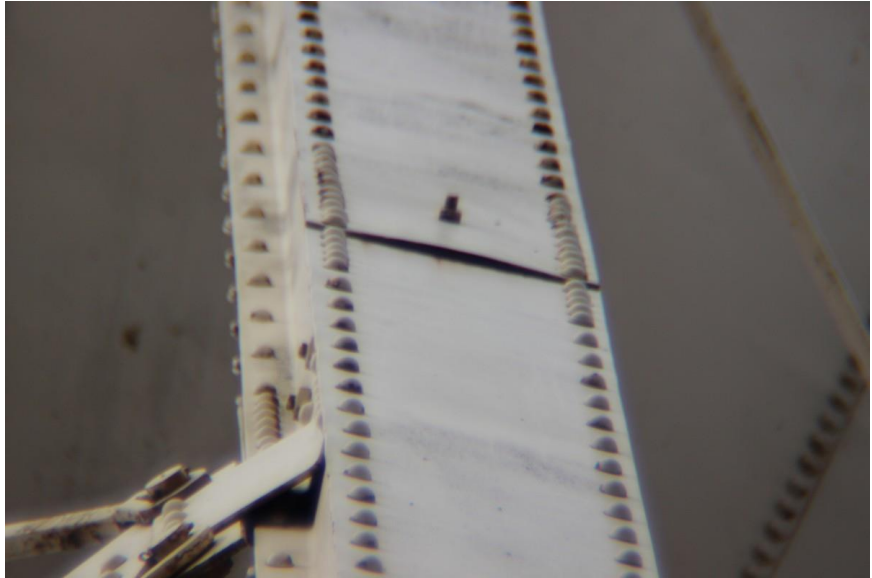
OBSERVATIONS	REFERENCE PHOTO
24. Another instance of rust jacking. While this plate is in better condition than others, it can be expected to continue to degrade.

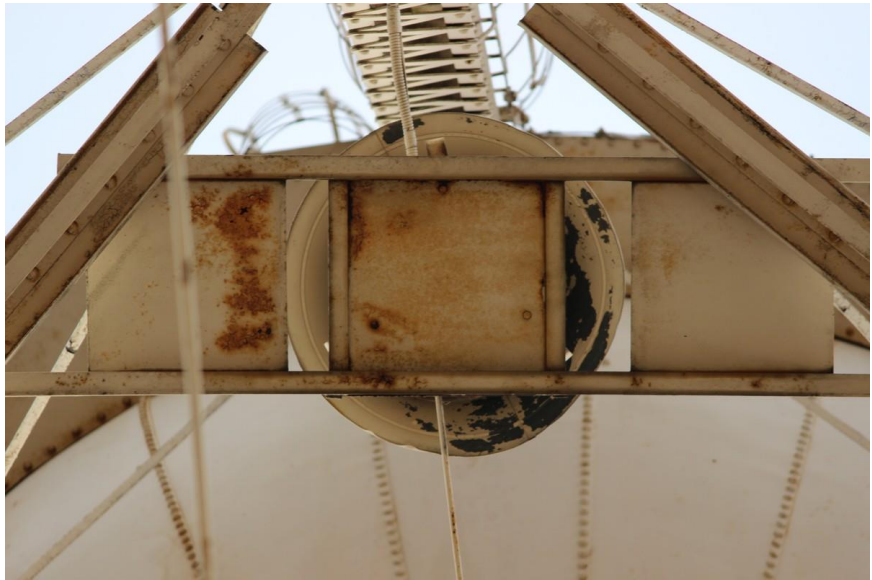
25. A horn sits on a platform perched atop two horizontal steel girders, requiring an electrical conduit running up the northwest leg from the ground. The horn and platform contain surface rust and weathered paint, but no major deficiencies. It is unknown if the horn is functional.

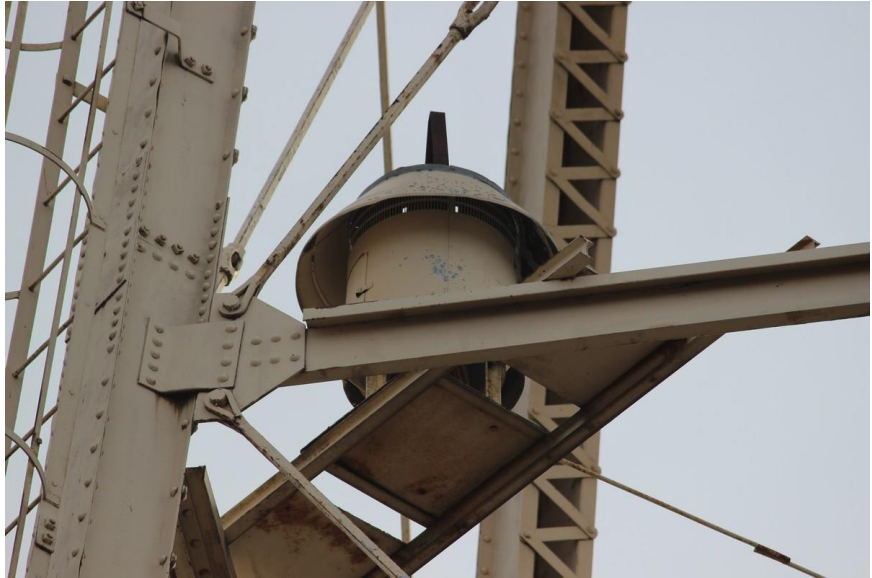
OBSERVATIONS	REFERENCE PHOTO
<p>26. Horizontal girders are connected to the legs with steel angles and rivets. There are eight total girders, connected just below the seams between leg sections. All girders appear to be in average condition, with just some rust, weathered paint, and lichen noted on their surfaces.</p>

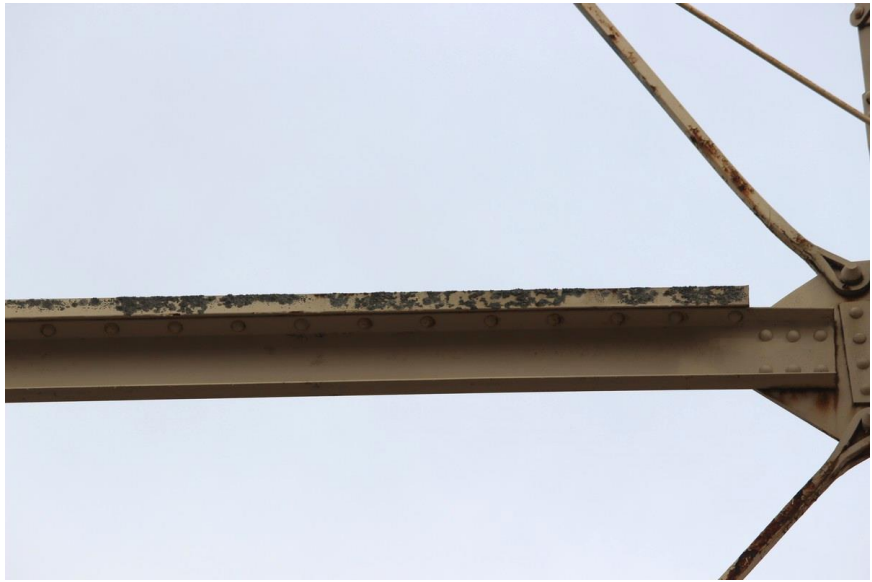
<p>27. Lichen is growing on horizontal girders.</p>

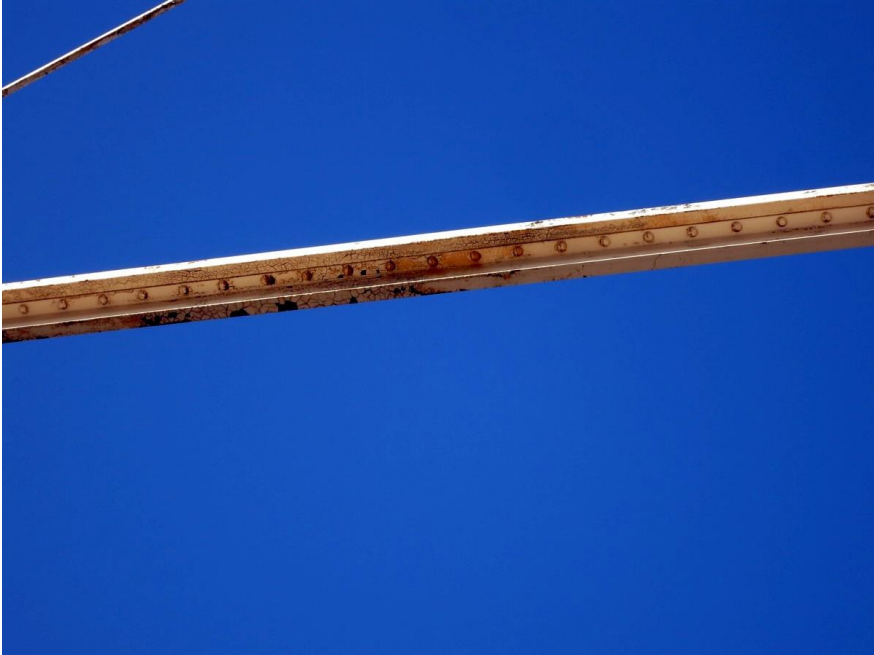
OBSERVATIONS	REFERENCE PHOTO
<p>28. Rust and chipped paint is evident on the surface of horizontal girders.</p>

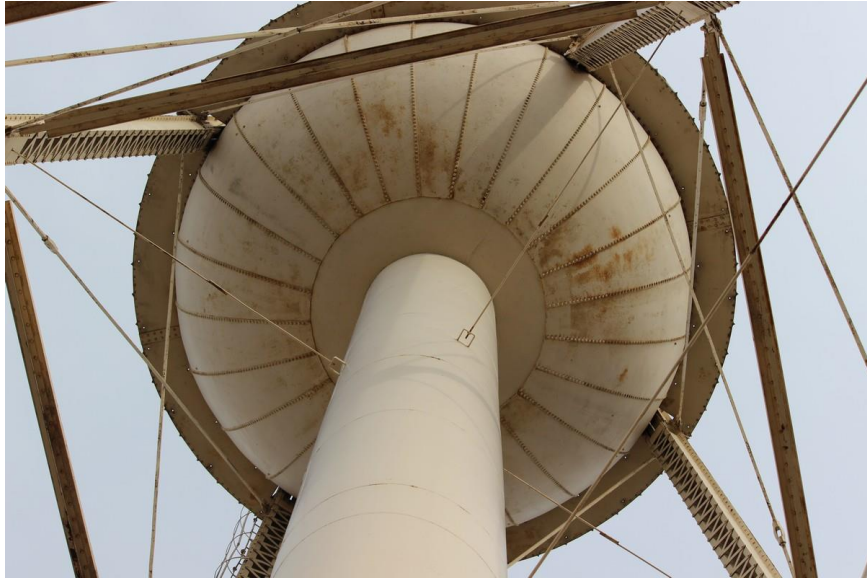
OBSERVATIONS	REFERENCE PHOTO
34. The standpipe enclosure extends from the ground to the underside of the tank.

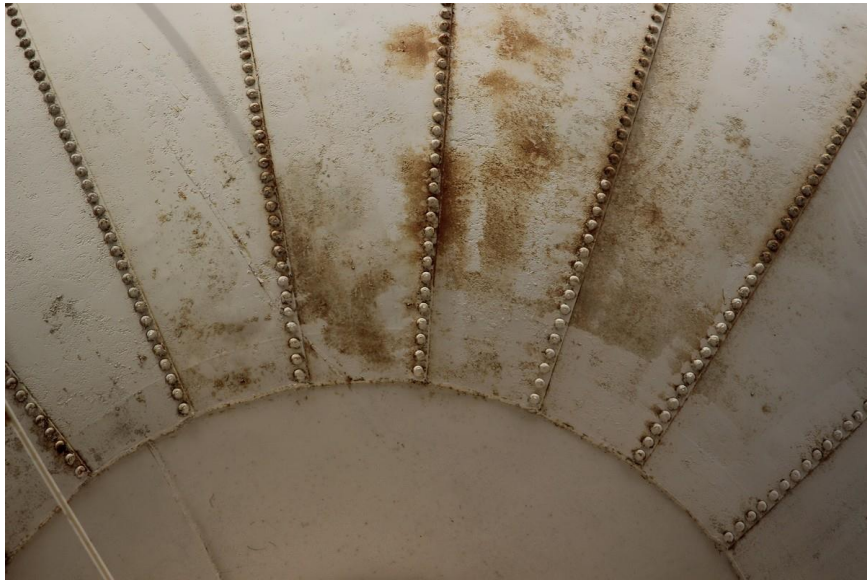
35. The underside of the tank is in average condition, with some rusting and weathered paint.

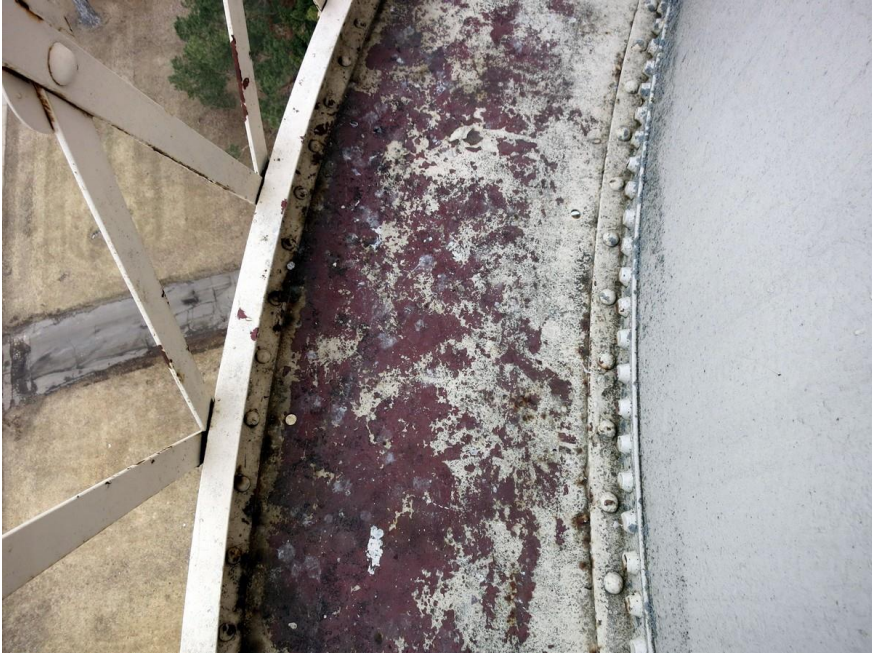
OBSERVATIONS	REFERENCE PHOTO
<p>36. The walkway platform surrounding the tank is in average condition, with weathered paint.</p>

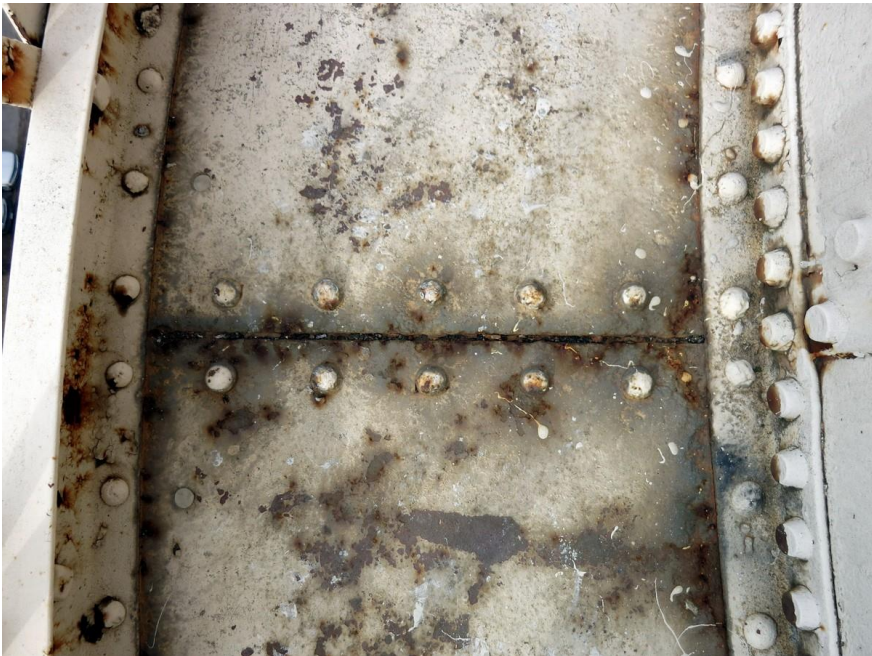
<p>37. Sections of the steel plate walkway are riveted to steel splice plates beneath the platform.</p>

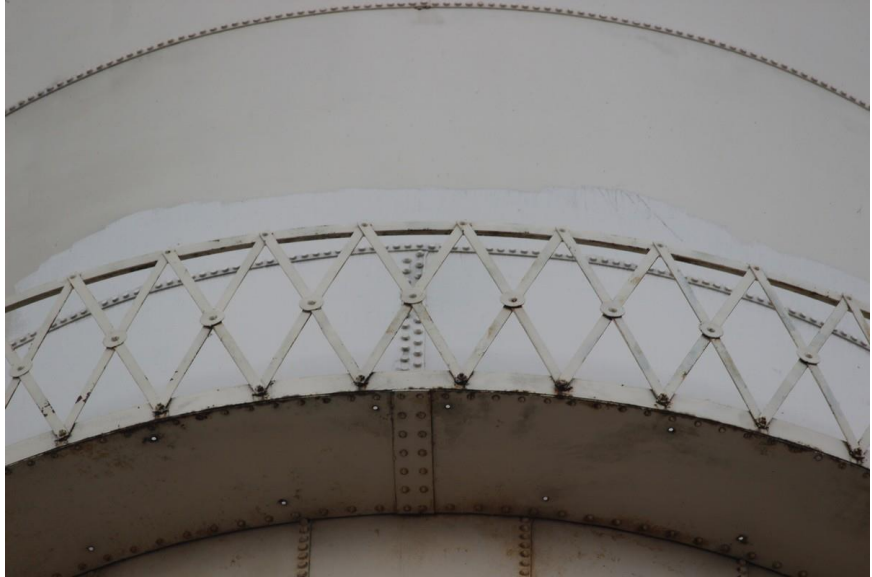
OBSERVATIONS	REFERENCE PHOTO
<p>38. Steel plates and rivets beneath the walkway platform connect the sections of steel walkway plates. The walkway has a latticed steel guardrail, which - like the platform - is weathered but in average condition.</p>

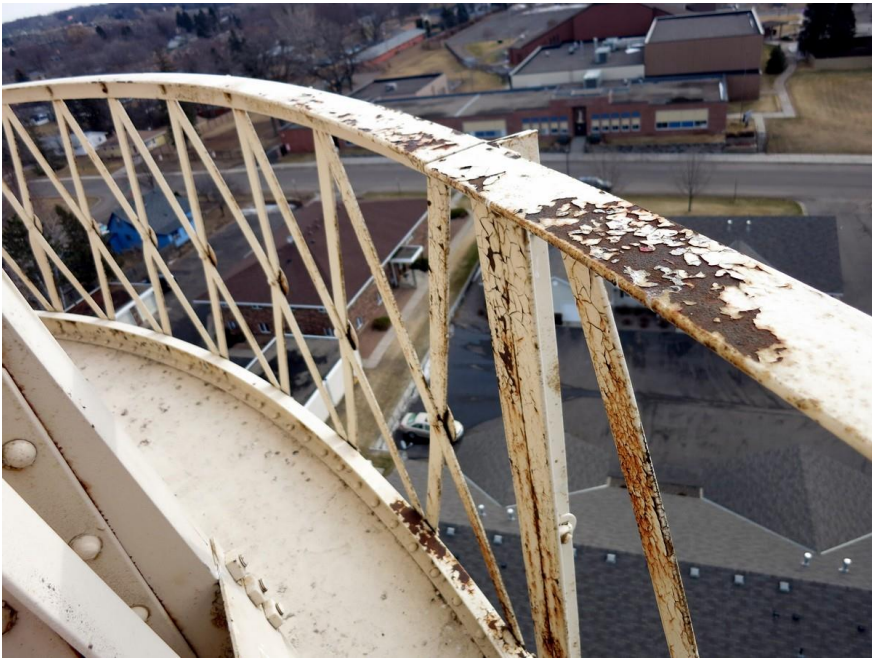
<p>39. The latticed handrail around the tank is in average condition overall, but features many areas of chipped paint and rust.</p>

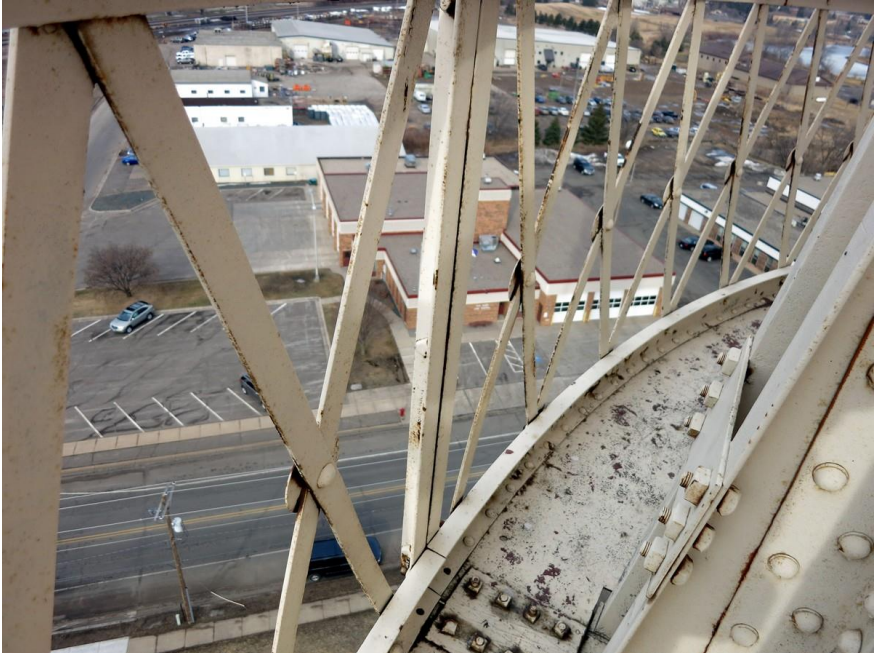
OBSERVATIONS	REFERENCE PHOTO
<p>40. The latticed handrail around the tank is in average condition overall, but features many areas of chipped paint and rust.</p>

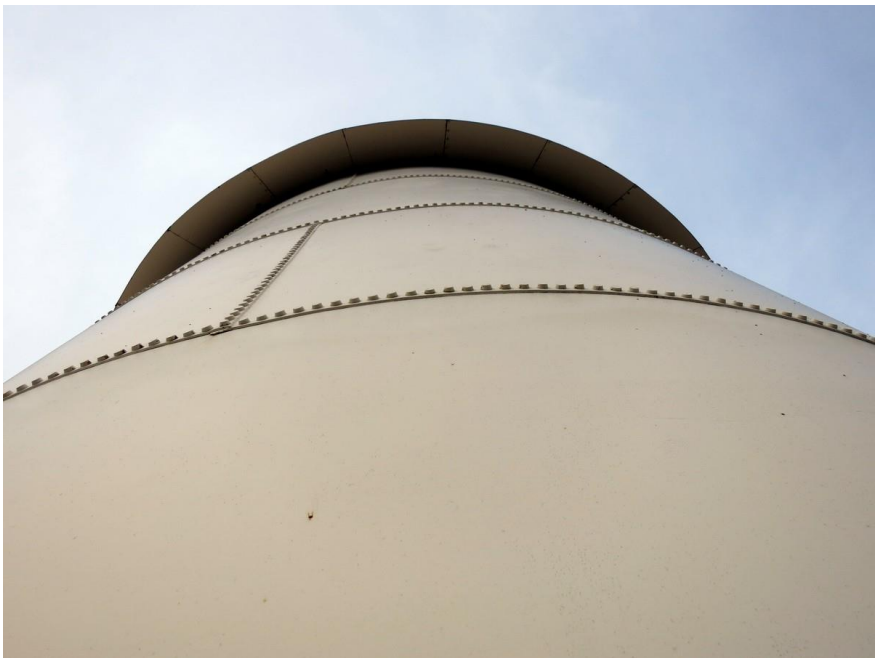
43. The side of the tank is in average condition.

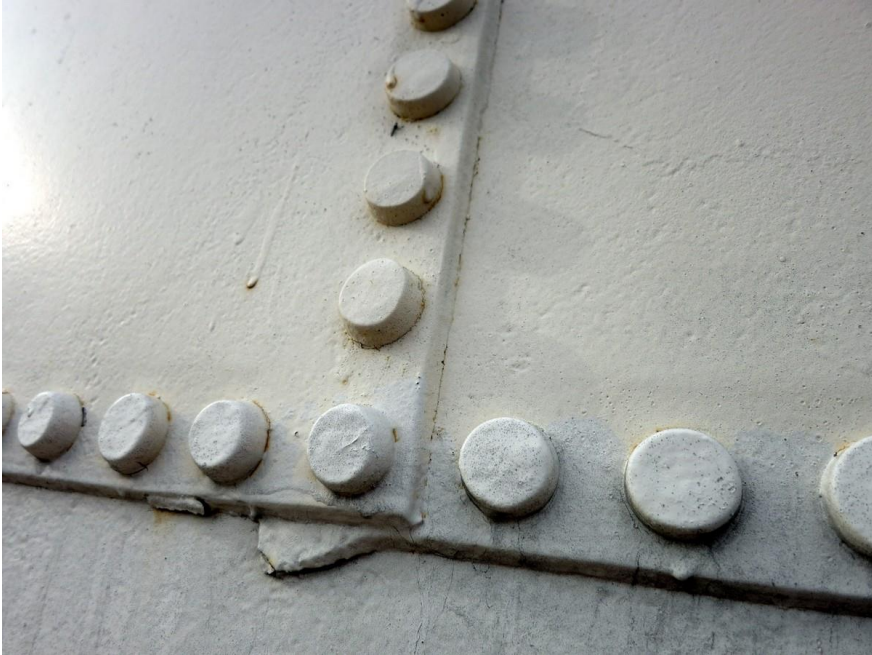
OBSERVATIONS	REFERENCE PHOTO
<p>44. The side of the tank is in average condition.</p>

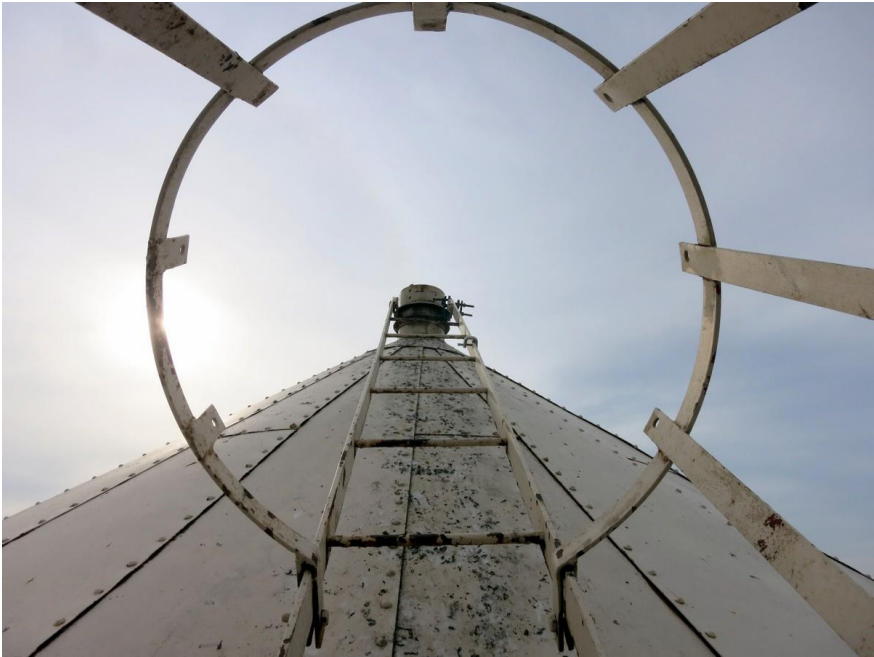
OBSERVATIONS	REFERENCE PHOTO
<p>46. A third ladder allows access to the conical roof of the tank and the cap on the very top of the Water Tower. This ladder can disconnect from the second ladder, and pivot around the cap at the top to provide access around the entire circumference of the roof.</p>

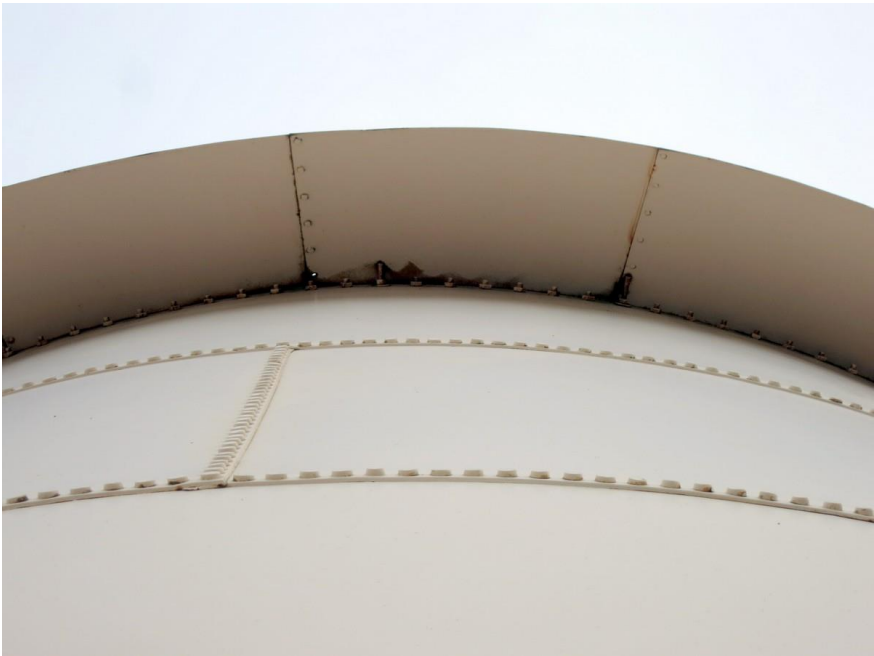
<p>47. Some minor rusting and water staining was observed at seams and the edge of the tank on the underside of the roof eave.</p>

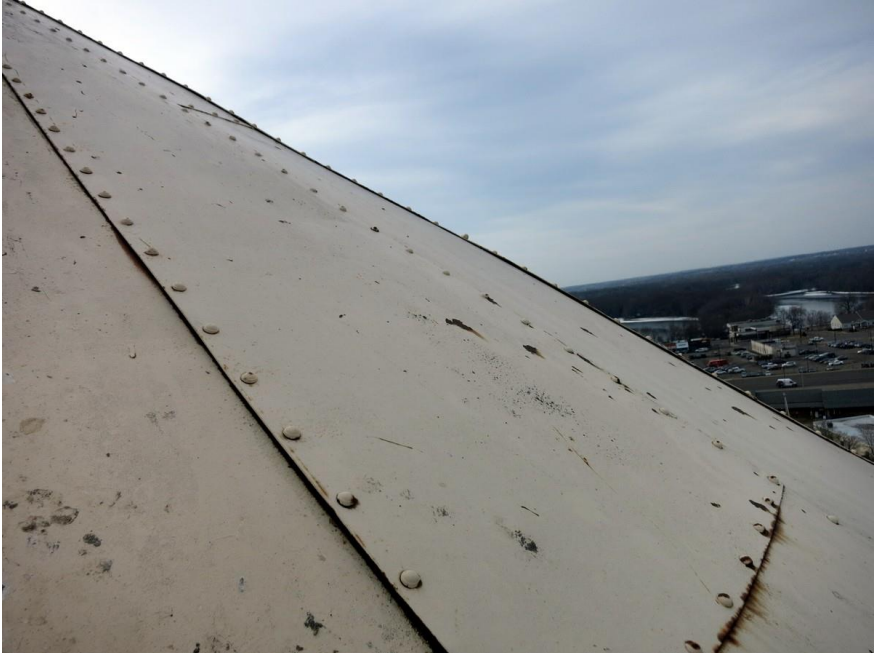
OBSERVATIONS	REFERENCE PHOTO
48. The conical roof is rusting at panel seams.

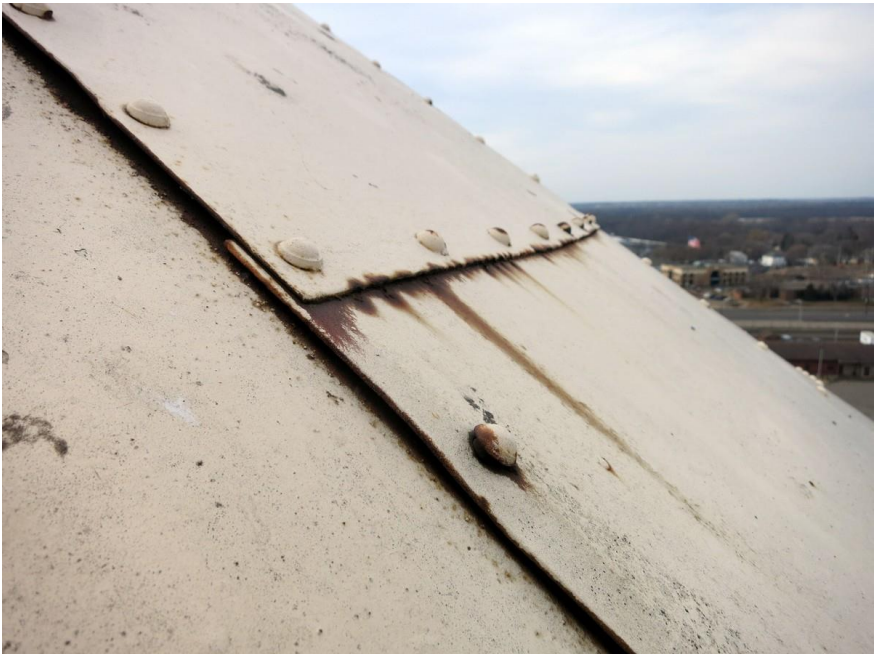
49. The conical roof is rusting at panel seams.

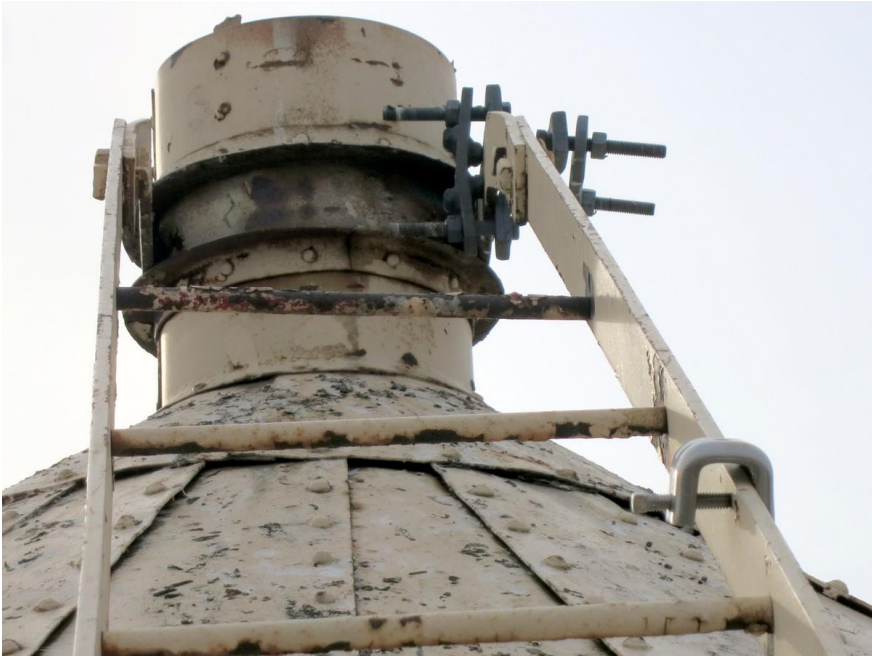
OBSERVATIONS	REFERENCE PHOTO
50. The cap atop the roof appears to be in average condition.
