Agenda Item: Discuss Water Tower Issues

CONDITIONS ASSESSMENT FOR THE OSSEO WATER TOWER

415 CENTRAL AVENUE
OSSEO, MINNESOTA 55369

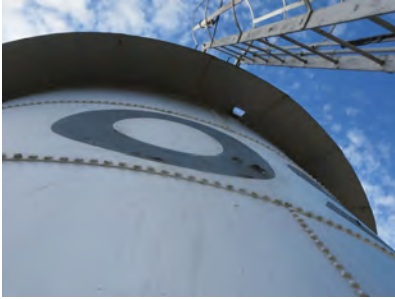
Flaking paint on the “O” on the north side of the tower.

The exterior of the tank appears to be in good condition, but there are a few minor condition issues. The paint is flaking in areas. The damage to the coating is most prevalent on the hemispherical bottom at the seams and on the rivets. The paint damage on the cylindrical portion of the tank is mostly on the black letters. In addition to the paint condition, the surface of the steel itself is damaged in some areas. There are little divots and dents, which are likely a result of improper paint removal techniques.

We recommend the coating be removed from the tank using the gentlest means possible and that it be repainted. Paint removal from a structure such as this is very difficult. Access can be a problem because the structure is so far off the ground. There are also many seams, rivets, and semi-concealed places that make using a typical chemical paint stripper impossible for some portions of the structure. Lead safe procedures also need to be followed for the paint removal, as tests in 2013 confirmed that the exterior paint contains lead.

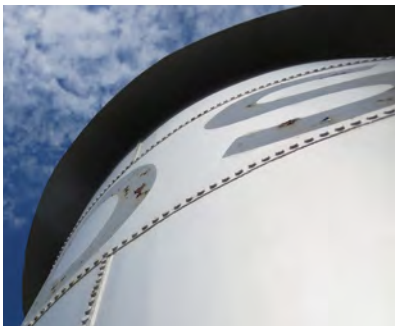
Paint damage on the tank exterior.

After the paint is removed and all debris and loose rust is removed from the structure, we recommend it be repainted with a high-performance coating, such as is manufactured by the Tnemec Company or PPG. We recommend that the tank have a zinc/epoxy/urethane system that is specifically rated for use on steel water tanks. The high-performance system must be compatible with both the steel substrate and its various primer, layers, and top-coat.

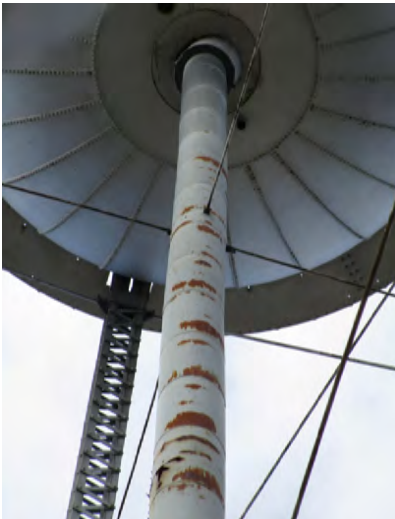
Photograph of riser shaft showing the corroded steel and the insufficient joint between the shaft and the tank.

The connection between the tank and the riser shaft has not withstood the amount of movement caused by wind. This has caused the riser to tilt. In addition, most of the sheet metal panels have corroded and the concrete is visible through some of the holes. Several of the panels are also dented.

The connection detail between the pipe and the expansion joint cover needs to be redesigned to withstand the dynamic movement of the tank. The damage to the sheet metal is likely due to water infiltration through the top of the shaft. See the structural section of this report for more information about a new structural joint. In addition to a new expansion joint and cover at the top of the shaft, we recommend that the sheet metal panels that have holes or dents be replaced with new galvanized steel. We recommend that the overlapped joints of the steel riser sheets be properly sealed so that wind-driven rain cannot enter the seams between the steel sheets.

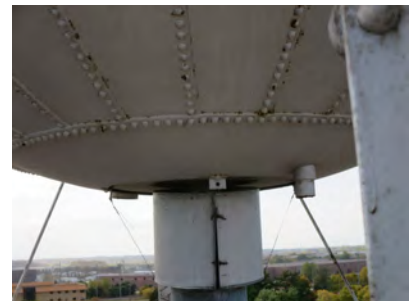
Expansion joint between the riser and the tank.

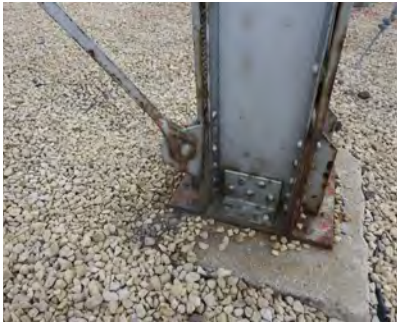
Erosion at southeast concrete footing and corrosion at steel.

The foundation of the water tower is concrete. There is some damage to the exposed portions of the concrete, especially at the northwest leg of the tower. The top of the concrete on the interior of this support is also spalling off. All of the steel legs have some corrosion at their bases near the concrete.

The damage to the concrete appears to be from salt from the adjacent driveway. Although some salt exposure may be unavoidable, we recommend that snow not be piled up on the gravel underneath the tower. Please see the Structural Report for more information about the foundation.

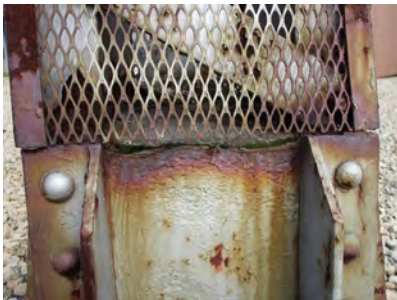
Corrosion and vegetation growth at base of southwest tower leg.

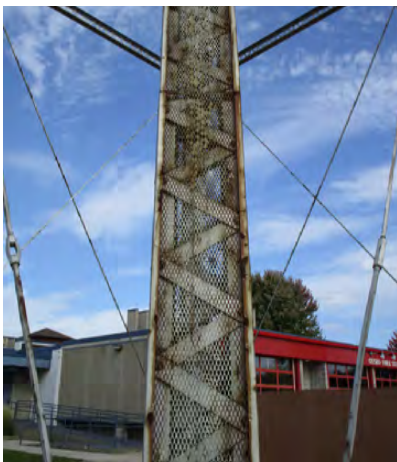
Corrosion at mesh on southwest leg of tower.

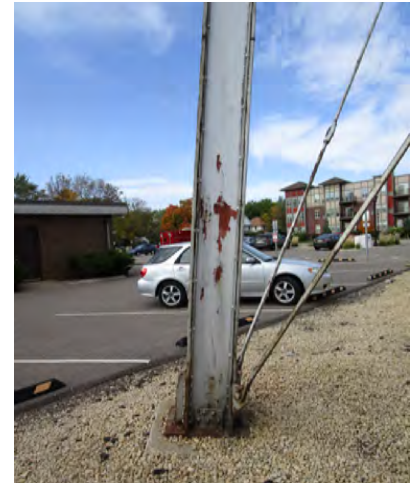
Peeling paint on southwest tower leg.

We recommend that all paint be removed, and the entire structure be repainted using the guidelines discussed in this report for the tank. Please see the recommendations about paint removal and recoating in that section.

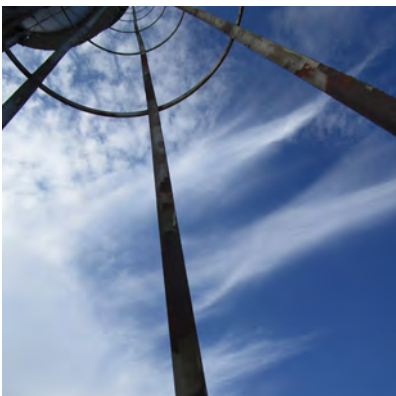
There are several safety and logistical issues with the access systems for the tank. The tower must be accessed on a routine basis to replace a light bulb at the top of the tower and carry out other maintenance. The main ladder up the side of the roof is in decent condition, but there are a few issues. The paint is flaking off the ladder. The treads also have poor traction. Some of the metal hoops and connection pieces on the cage are slightly bent and the paint is peeling off.

Peeling paint and exposed steel on the ladder cage.

If the safety consultant determines the ladder and cage should remain, we recommend that they be painted when the rest of the water tower is painted. We also recommend that an anti-slip tape or other skid-resistant

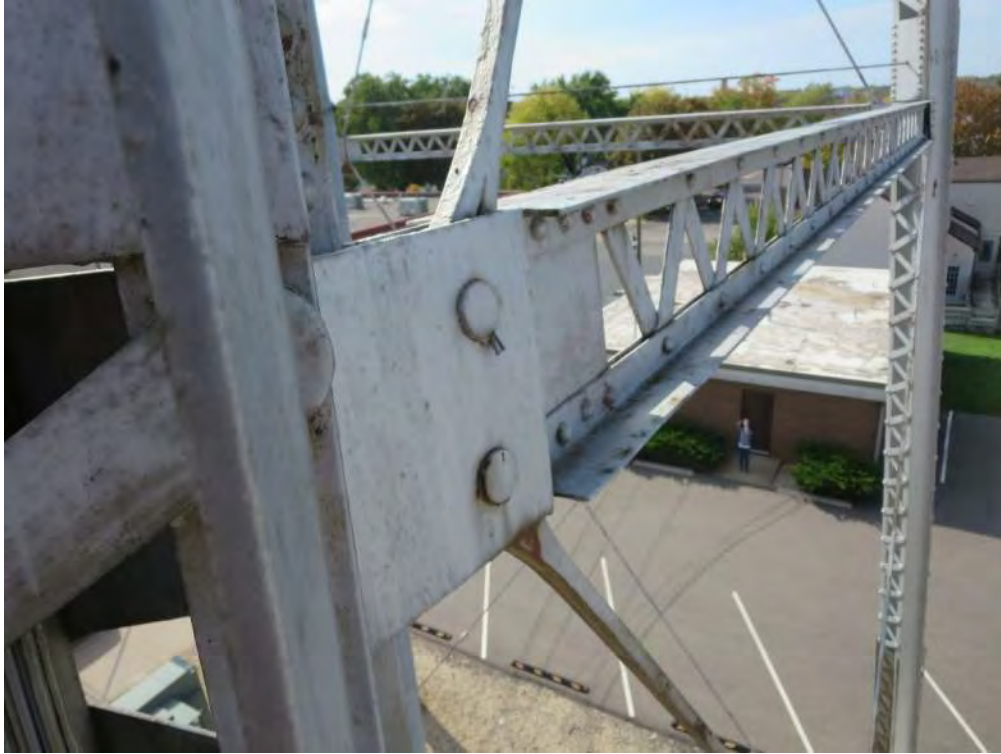
Some of the cotter pins are damaged or missing from the pinned connections of the cross rods.

Photo 6 - Horizontal beam - note top cotter pin broken at top, bottom cotter pin missing

We recommend that new cotter pins be installed in these locations. Please see the structural section of this report for more details on the cotter pins and for the full structural conditions assessment and recommendations.

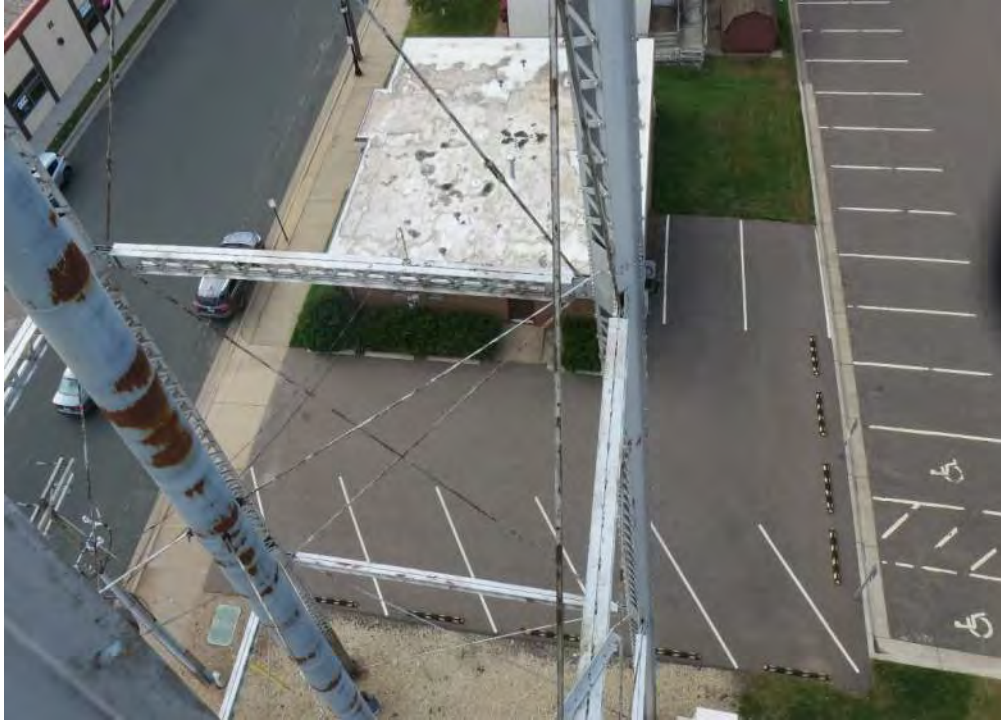
Photo 8 - Looking down at bracing - note rust and deteriorated paint

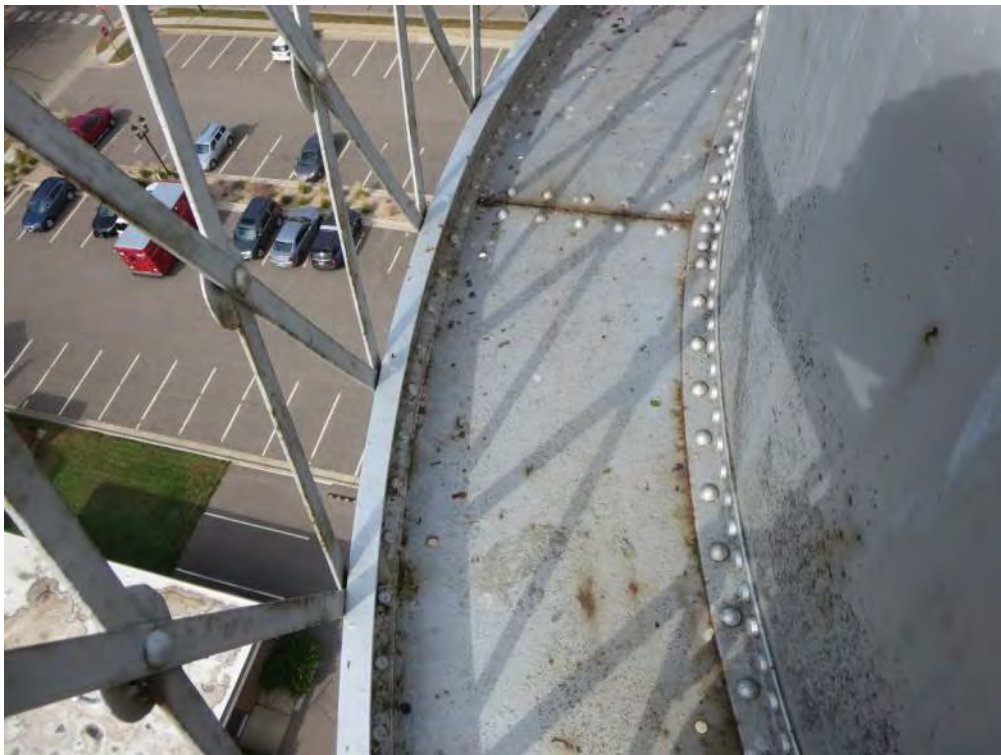
Photo 9 - Walkway around tank - note surface rust

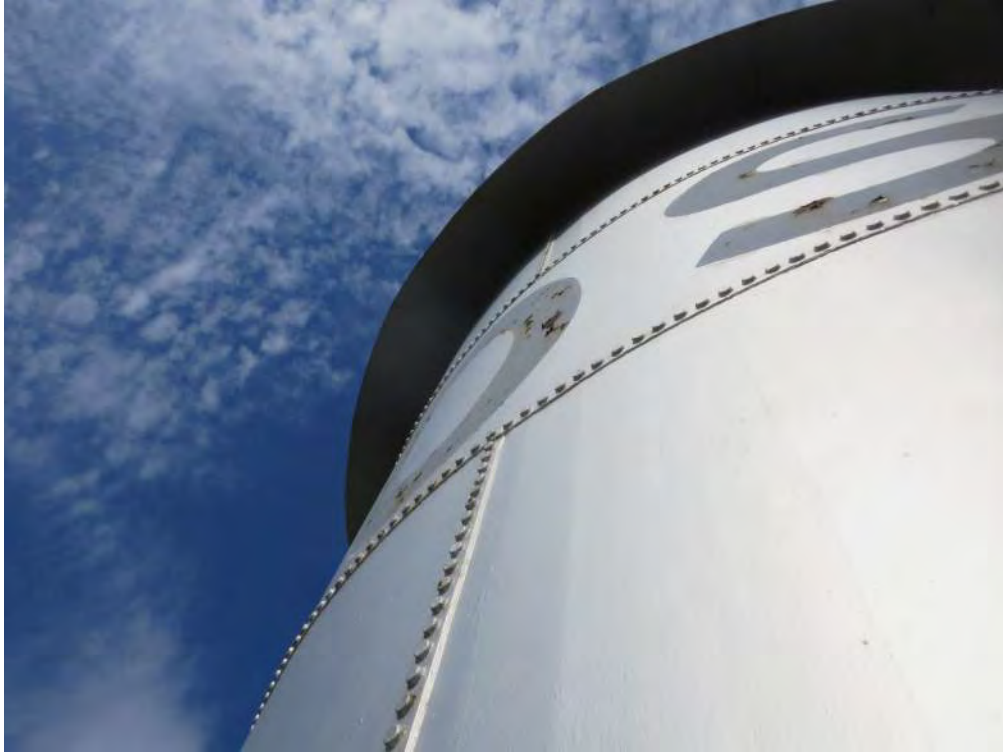
Photo 10 - Tank wall - note pealed paint and rust in letters

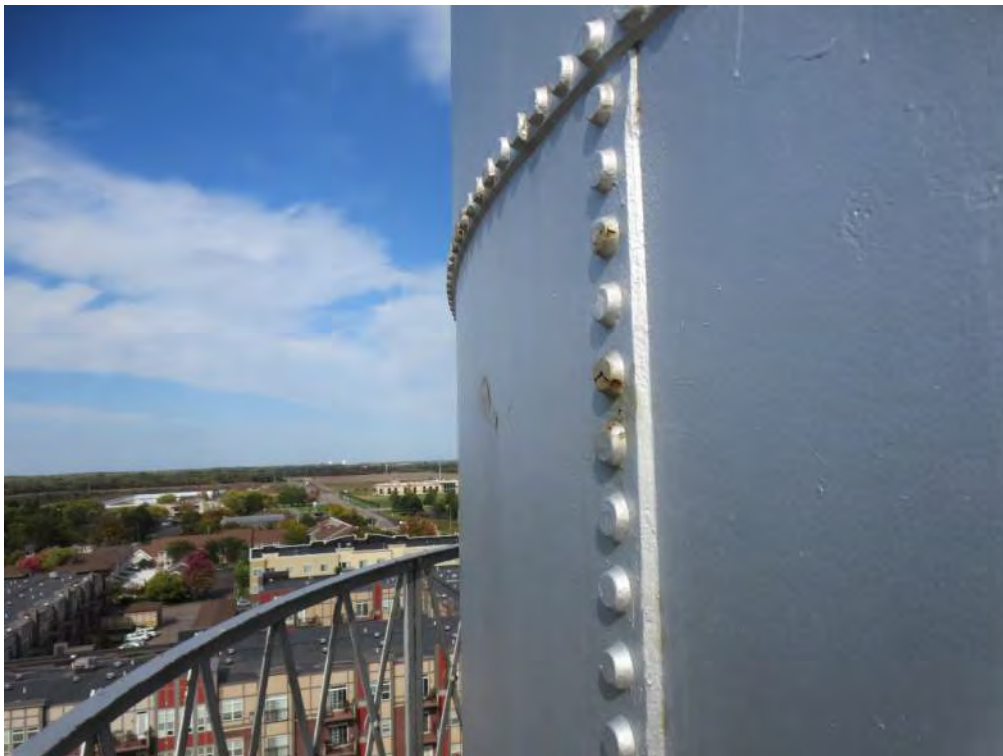
Photo 11 - Tank plate joint - rust evident at some rivets

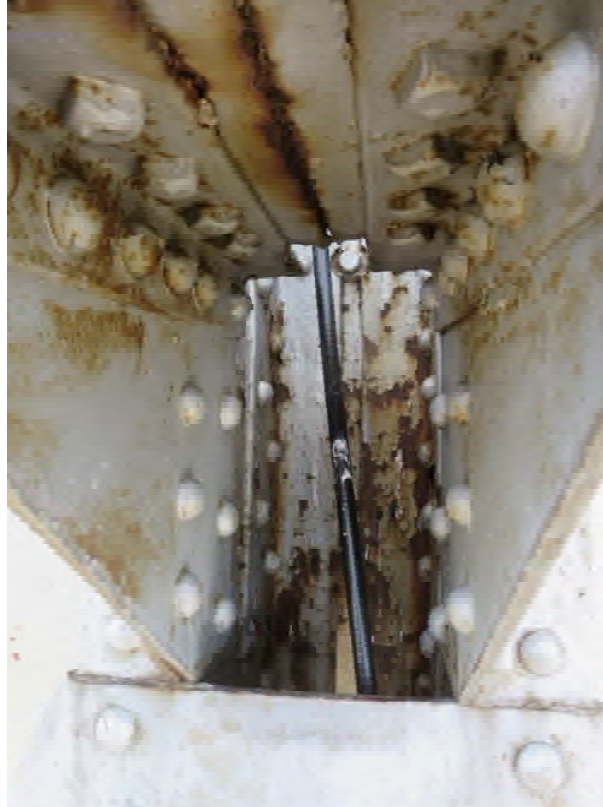
Photo 12 - Support bracket below walkway - surface rust and some deterioration evident

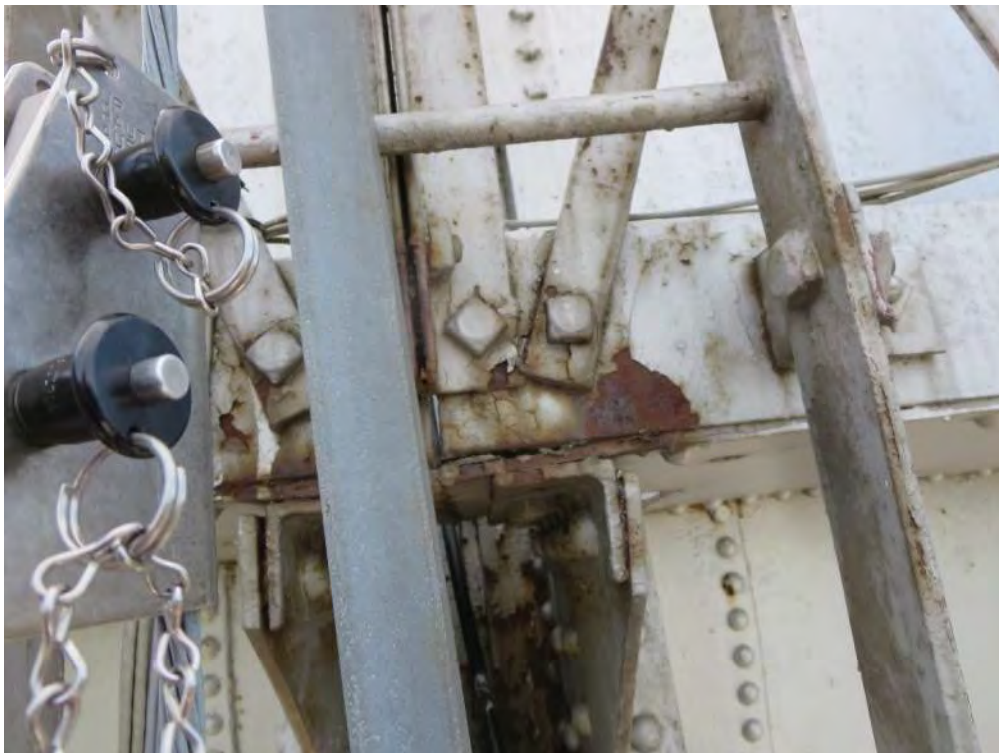
Photo 13 - Ladder connection to walkway - note rust and peeled paint

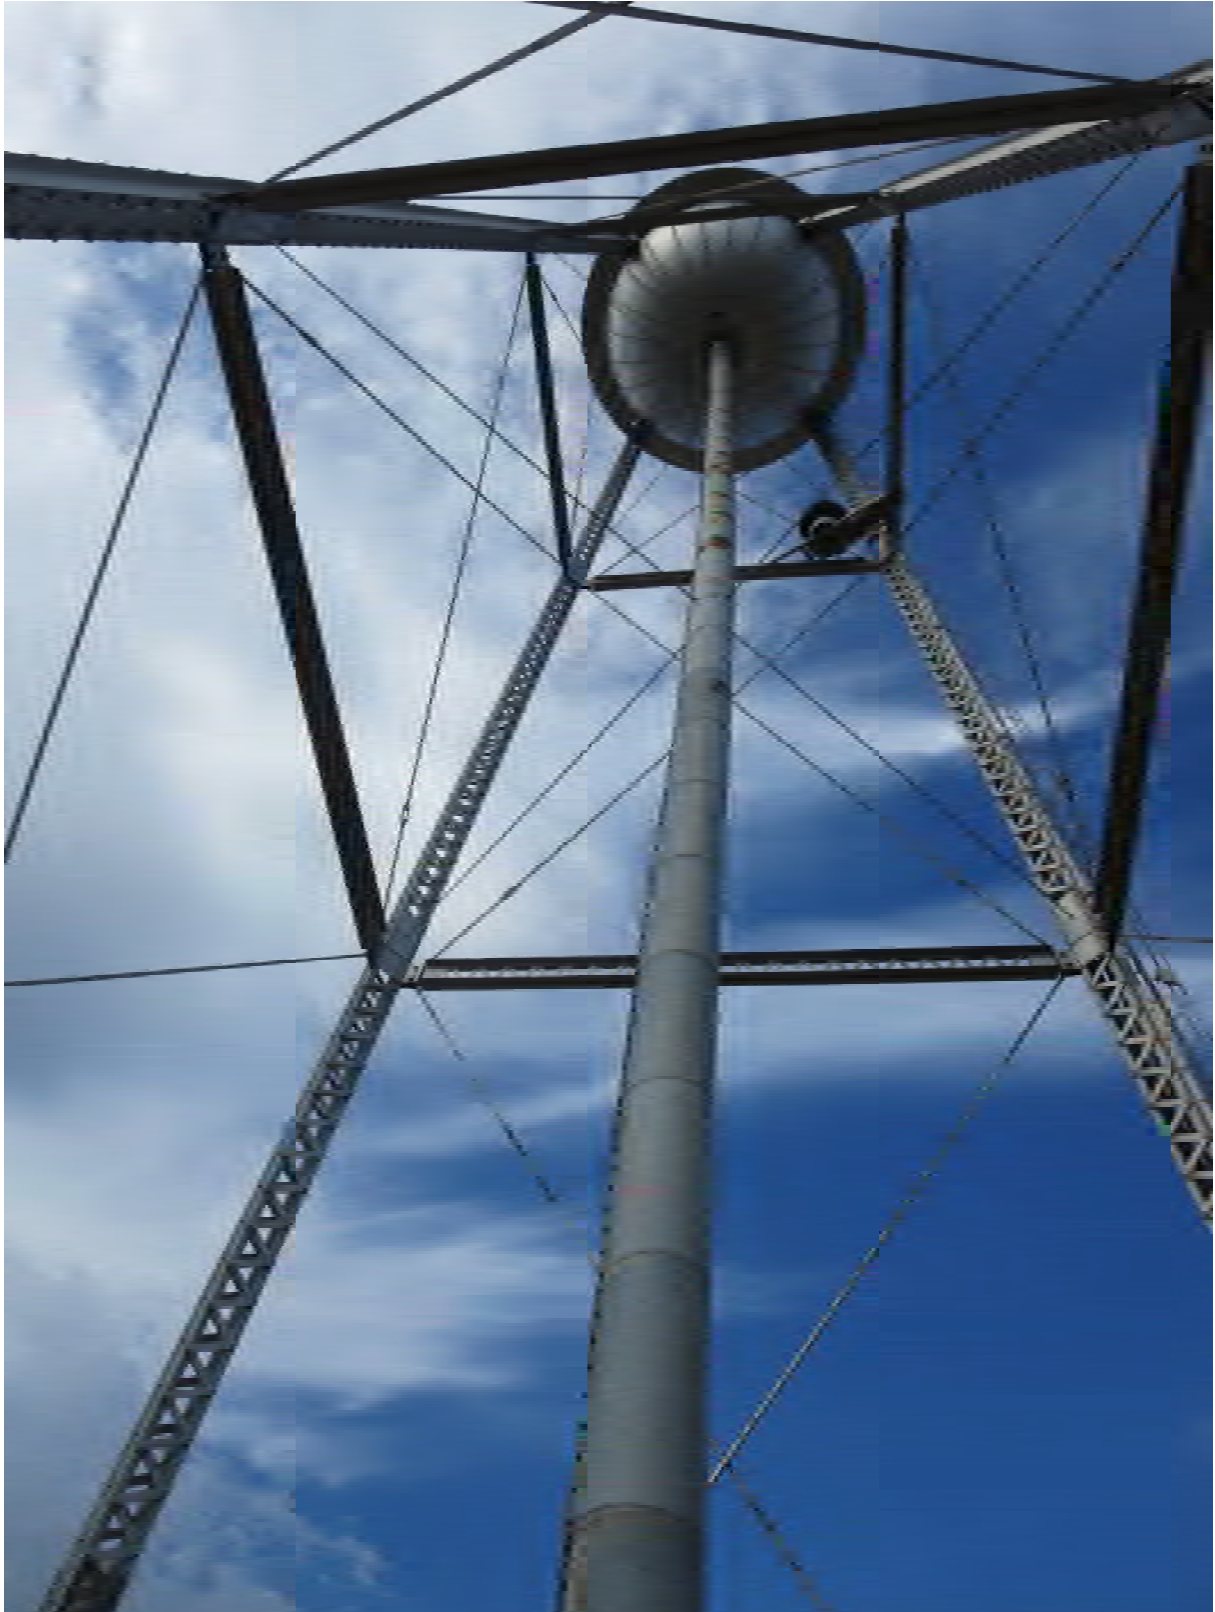
Photo 15 - Base of tank and bracing - note dark spots on bracing are surface rust locations
