Osseo City Council Meeting

WORK SESSION

Attachments: KLM Engineering Report from June 2013
Emails from Council member Johnson
Conditions Assessment from Elk River

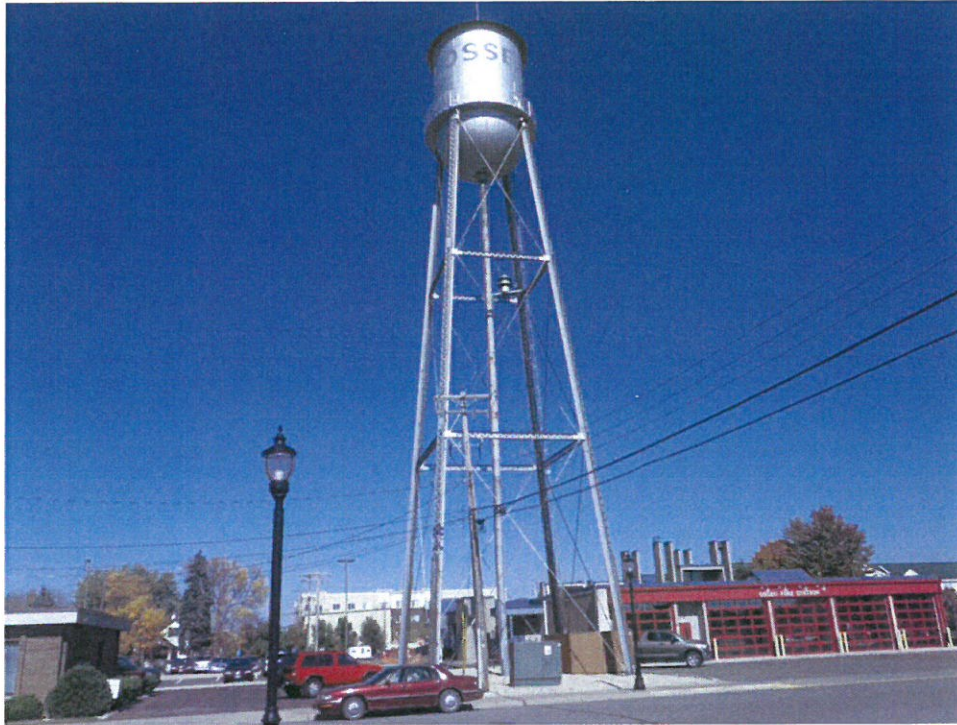
Photo No. 1
Overall view of North Tower

- 3.4.8 Containment will be required during abrasive blasting and painting of the exterior of the tower. The roof plate appears to be 3/16-inch thick which would not support either a roof or roof edge hand railing nor an exterior containment system to enclose the tower during exterior reconditioning. Additional modifications will be required either to the roof and shell in order to stiffen and strengthen those areas sufficiently to support the containment, or to the coating contractor's containment rigging supports. Past experience has shown the method varies by contractor and tank, but these costs alone can be as much as \$30,000. This cost would be in addition to the costs of abrasive blasting and painting, and are included in the mobilization portion of the Engineer's Cost Estimate. See photos 1, 2 and 9.

- 3.5.1 It is unknown when the exterior of the tower was last coated. The exterior coating is in fair to poor overall condition, and due to age, chalking, and deterioration, the exterior coating cannot be repaired or over-coated. The coating on the entire exterior of the tower should be removed by abrasive blasting to an SSPC-SP-10 Near White Metal Blast Clean and replaced with a zinc/epoxy/urethane coating system, similar to those manufactured by the Tnemec Company. See photos 1 through 28.

- 3.4.4 To prevent trespassing, install a padlock on the roof access manway. The cost of a new lock is not included in the Engineering Cost Estimate.
- 3.4.5 Remove the connection to the roof vent and weld the sections of the ladder to the roof. Install an OSHA-compliant pipe-style handrail around the entire roof edge, directly above the shell, to enclose the roof manways and roof ladder. Vertical pipe members shall include appropriately sized repads at the roof connection, and be spaced at no more than 5-foot intervals. Install a swinging gate at the top of the shell ladder as required by OSHA. See KLM Drawings No. 18 and 20, and photos 1 and 9.

- 3.4.10 Past experience has shown there is a high degree of difficulty in abrasive blasting and painting the lattice legged areas on towers such as this. In a methodical manner, remove the lattices on the backside of the support columns and replace with solid plate, similar to the plate on the front of the support column. Seal weld the plate to the channel side members. This will enclose the interior of the support column and eliminate the need to abrasive blast and paint it. See photos 1, 2, 7, 9 and 15 through 28.

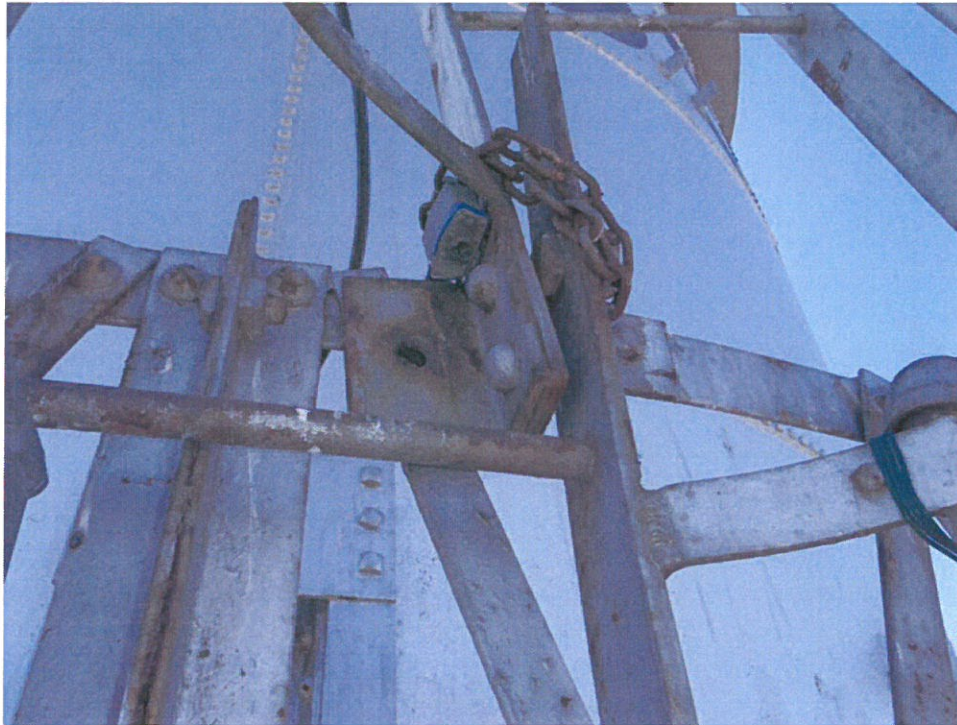
Photo No. 5
Tower access ladder from balcony to roof

- 3.4.1 The exterior ladder from the tower balcony to the roof appears to be broken and is not properly secured into place. The ladder is unsafe and climbing this ladder to the roof should not be attempted before repairs are completed. The shell ladder should be properly secured by welding support brackets to the ladder and tank shell, which will require cutting a section of the roof plate out. This will enable climbers to safely access the balcony prior to climbing the shell ladder to the roof. Perform any required modifications to the roof ladder to adequately secure it for the exterior roof and interior inspections. This is separate from item 3.4.5 below. See photos 2 through 8. [The ladder was modified by General Construction Services to facilitate access to the roof.]

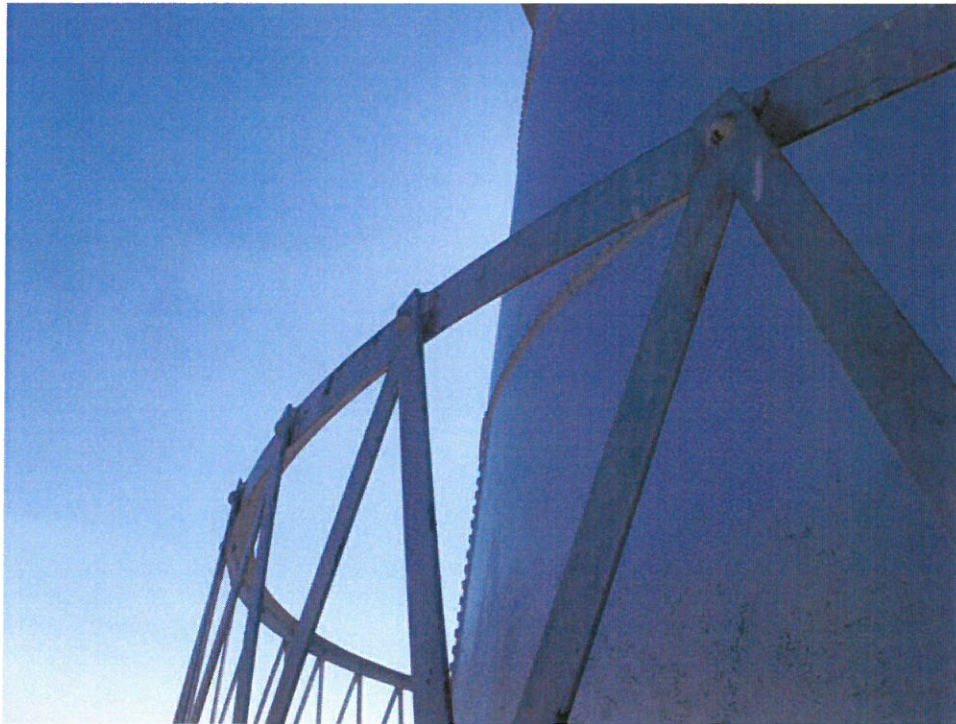
Photo No. 10
Balcony hand railing

- 3.4.6 The existing balcony handrail does not meet OSHA top-of-rail height requirements or the requirement for a mid rail and structural loading, and access from the leg ladder to the balcony is difficult and may be unsafe. Replace the handrail with a new, OSHA-compliant balcony handrail. See photos 1 through 11 and KLM Drawing No. 10.

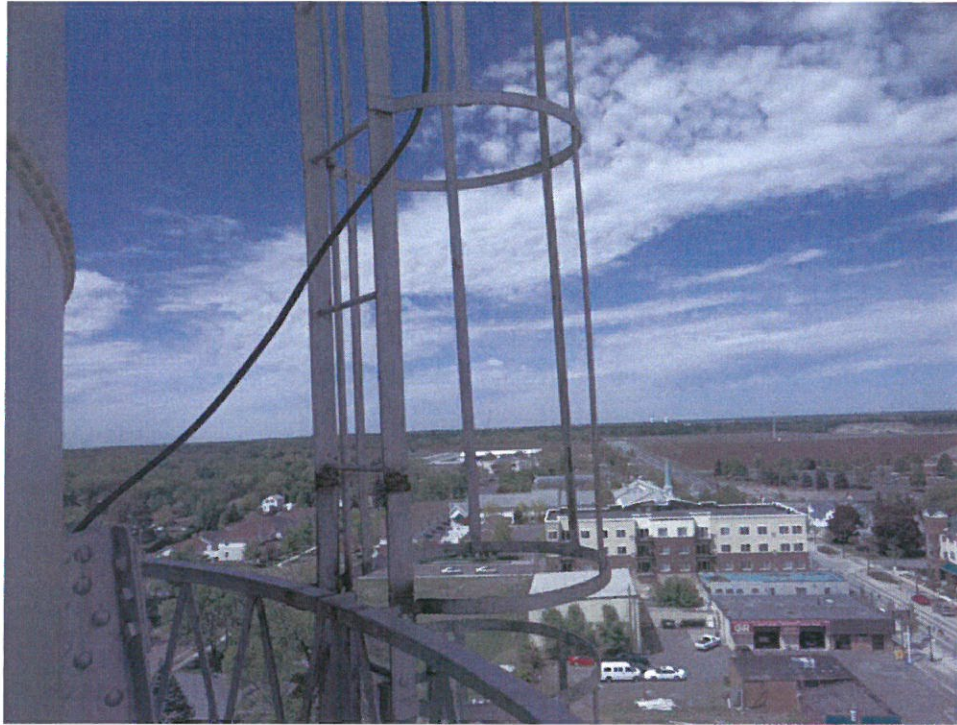
Photo No. 29
Shell ladder following modifications

- 3.4.11 [Additional weld repairs are required to complete the ladder modifications, as there are some incomplete welds on the ladder and safety cage members. Install two (2) additional support brackets on the roof ladder, which is now connected by two supports at the bottom and around the roof finial. See photos 29 through 34.]

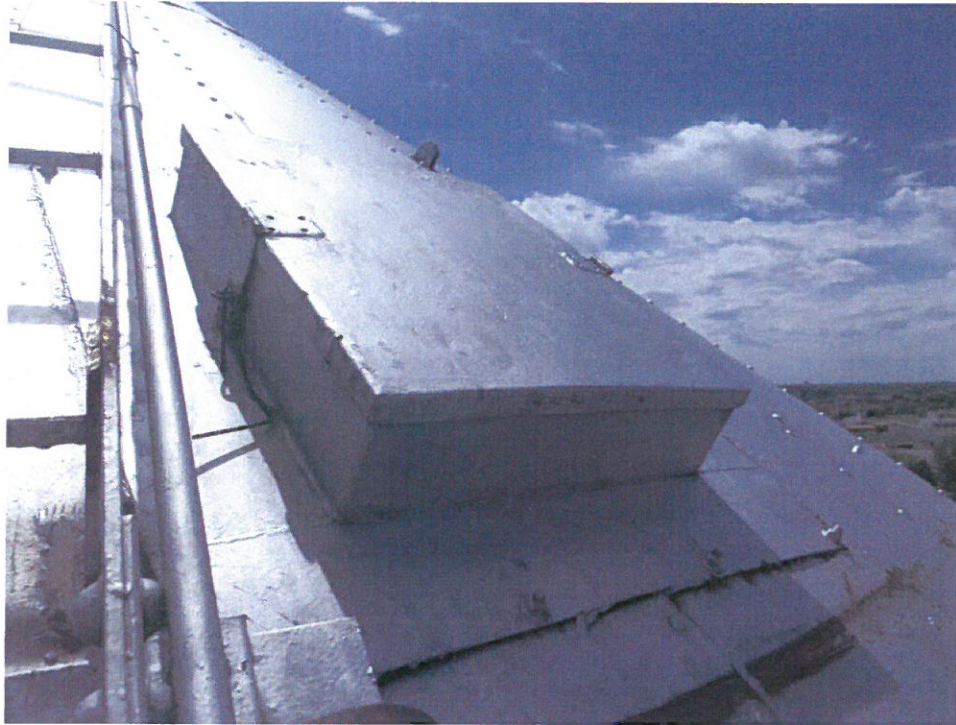
Photo No. 35
Roof access manway – note lack of lock

- 3.4.12 [The roof access manway has broken hinges and is difficult to open and close. Replace the one under-designed hinge with two heavy duty hinges. Install a lock on the roof access manway. See photos 35 and 36.]

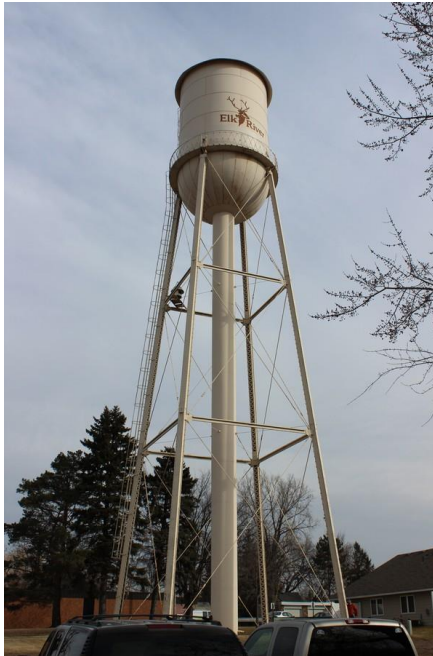
OBSERVATIONS	REFERENCE PHOTO
1. Each of the Water Tower's legs consists of two parallel steel channels, which are bracketed on the outside with a flat steel plate, and on the inside with small latticed bars.

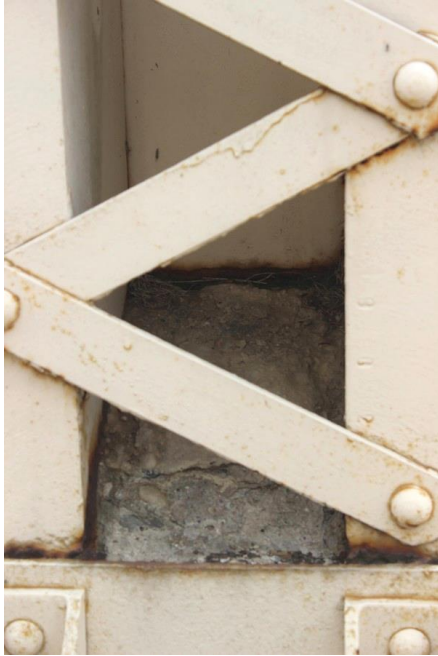
OBSERVATIONS	REFERENCE PHOTO
6. The inside of the base of each leg has been filled with concrete.

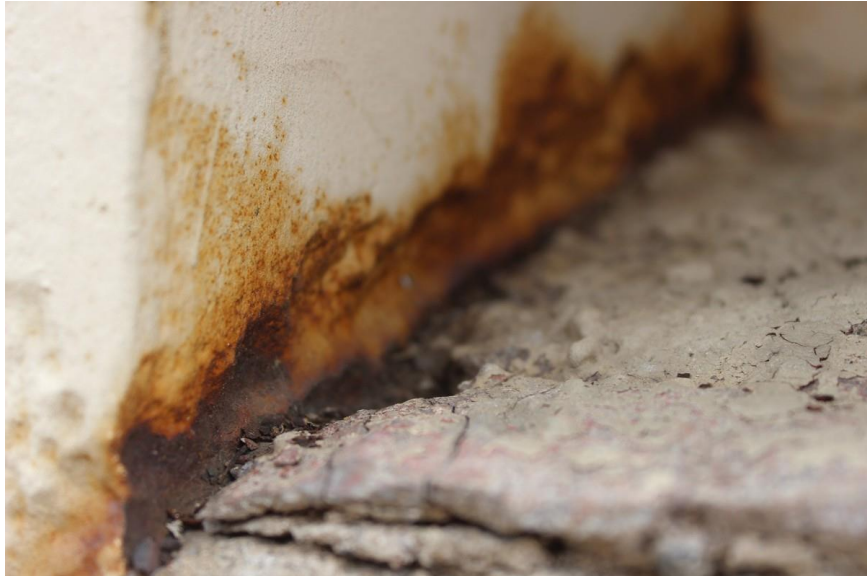
Two issues were observed, both located on the legs, which will need further maintenance beyond the obvious painting. The first issue relates to some corrosion of the steel at the base of the legs. This condition is hidden by the concrete that was installed to drain water from the legs. It would be important to investigate the condition of the steel behind the concrete further during the painting project by removing a portion of the concrete infill and inspecting the steel. If the corrosion is worse than what is observed presently, some remedial action may need to be done to strengthen the base, such as the addition of steel plates to replace the loss of cross sectional area due to corrosion.

OBSERVATIONS	REFERENCE PHOTO
<p>8. Water flows out of the legs along the steel at the edge of the concrete, which has caused the steel to corrode. Loss of cross-sectional area of the steel is occurring on the steel channels due to corrosion.</p>

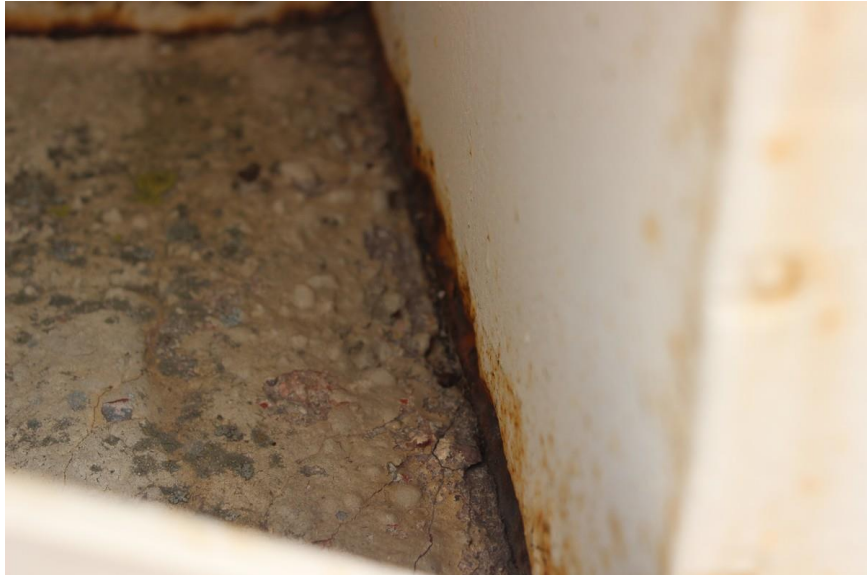
<p>9. Loss of cross-sectional area of the steel is occurring on the steel channels due to corrosion.</p>

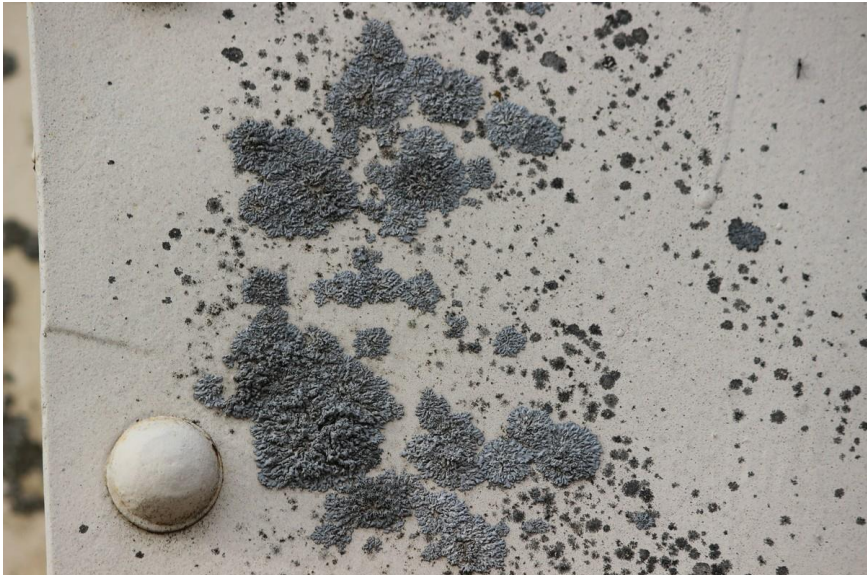
OBSERVATIONS	REFERENCE PHOTO
<p>16. Lichen (organic growth) is growing on the legs in some areas.</p>

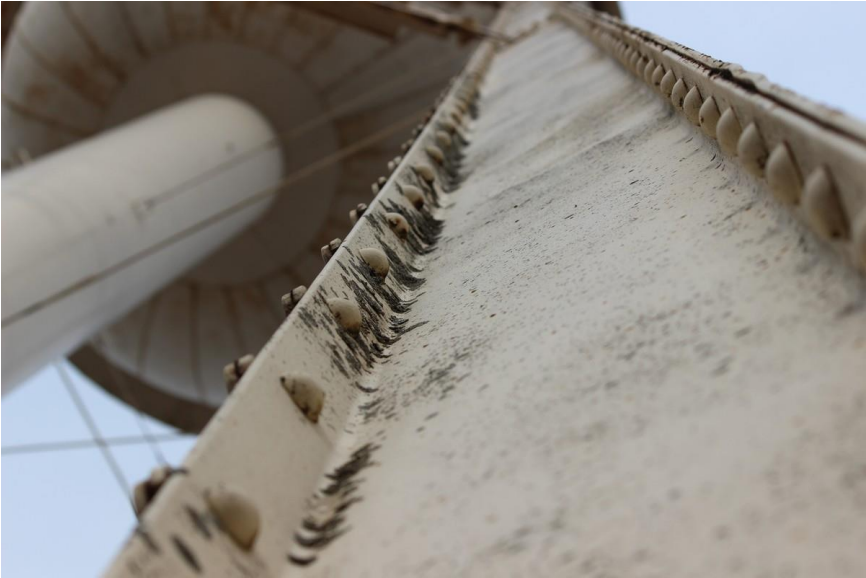
OBSERVATIONS	REFERENCE PHOTO
<p>18. The paint on the flat sides of the legs is weathered; lichen and corrosion was observed in some areas.</p>

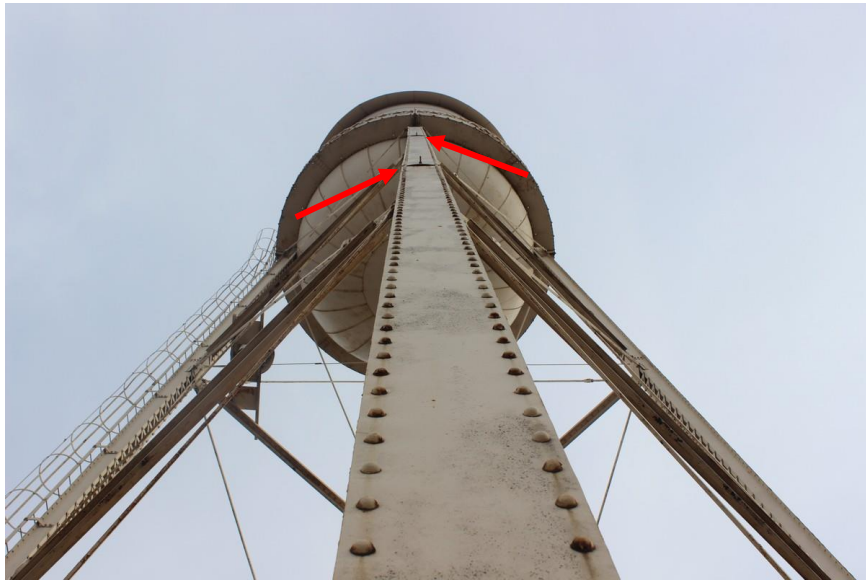
A close-up photograph of a water tower leg. The leg is a light-colored metal beam with a series of rivets along its length. The paint is significantly weathered, with dark, irregular patches of lichen and corrosion visible, particularly along the edges and around the rivets.
<p>19. Each of the Water Tower's legs is essentially made up of three sections, with the longest at the bottom and the shortest at the top. The leg sections are connected with steel splice plates on all four sides, with some plates inside the legs and some outside. Note the two exterior plates indicated in the photo.</p>

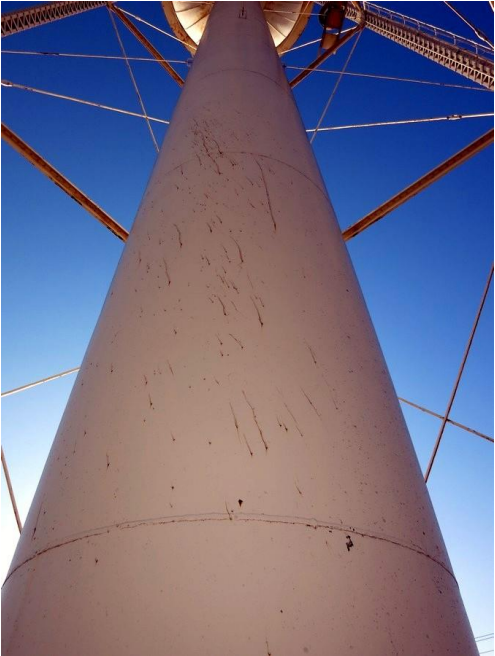
A close-up photograph of horizontal steel girders. The surface of the girders is heavily corroded, showing significant rust and areas where the paint has chipped away. The girders are set against a clear, bright blue sky.
<p>29. At the epicenter of the four Tower legs is vertical steel tube that encloses an eight inch stand pipe connecting the tank to the water system. Eight tie rods connect the center tube to the Tower's legs.</p>

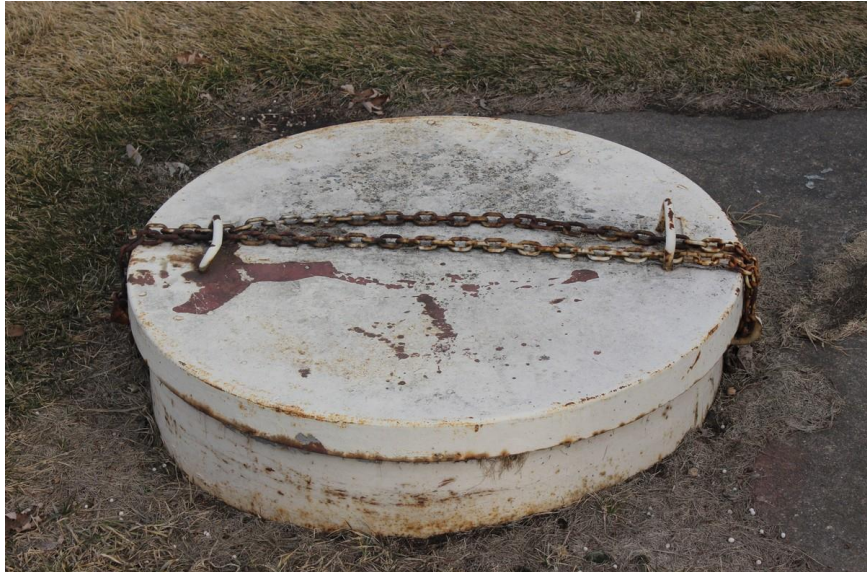
OBSERVATIONS	REFERENCE PHOTO
30. An access hatch leads underground underneath the Water Tower.

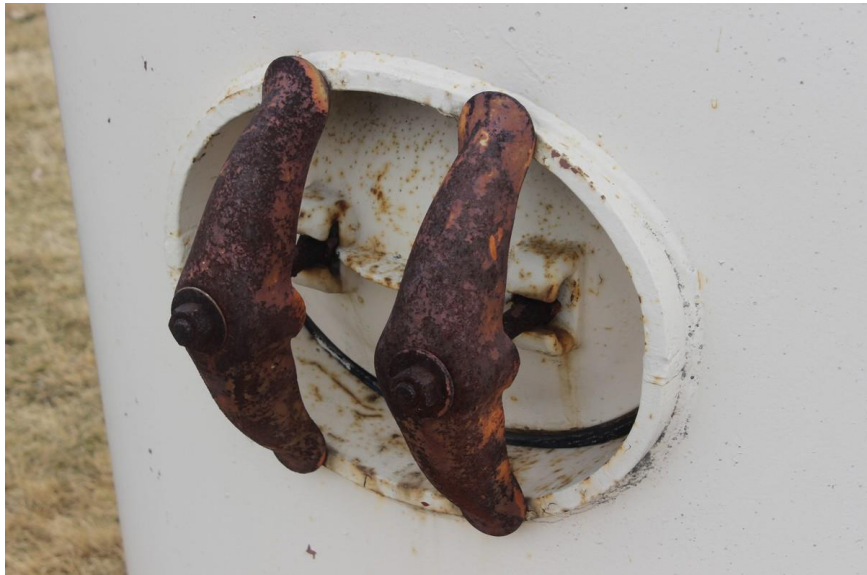
31. A small hatch allows access to the enclosed stand pipe.

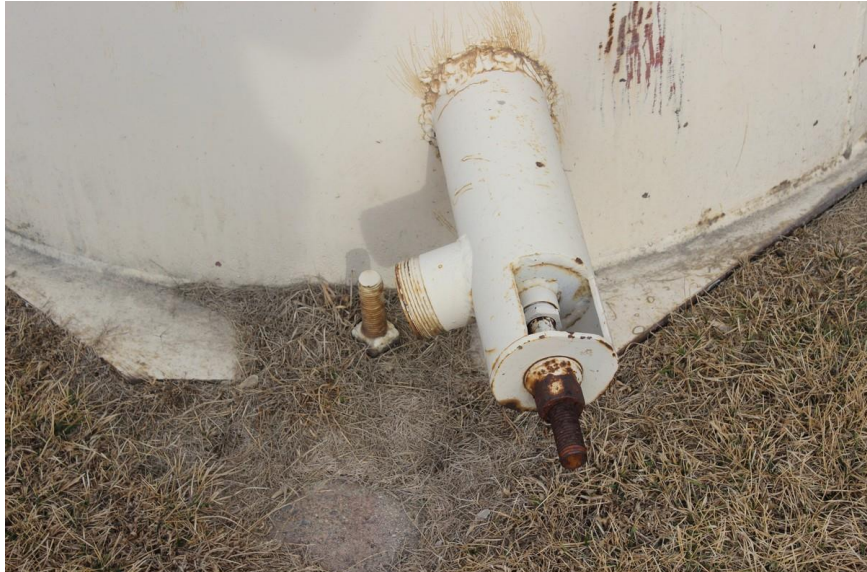
OBSERVATIONS	REFERENCE PHOTO
<p>32. Some minor rusting and weathered paint were observed on the vertical tube.</p>

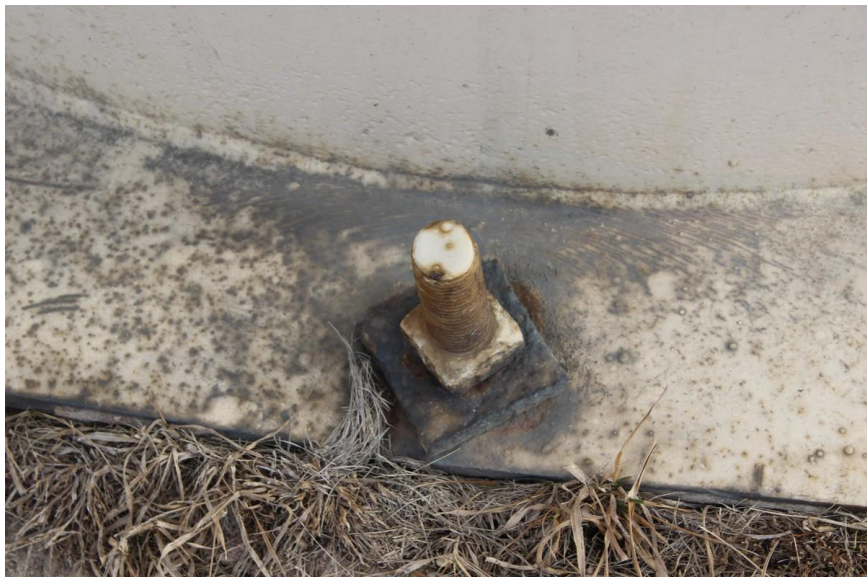
<p>33. The vertical tube is bolted into a concrete pad. The surfaces of the bolts are covered with rust and dirt, but are performing well.</p>

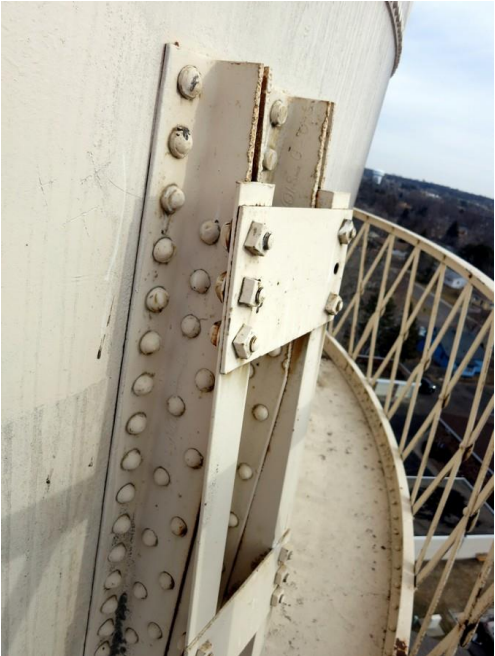
<p>41. The four legs extend inside the walkway platform and are connected with steel angles and rivets to the vertical surface of the tank.</p>

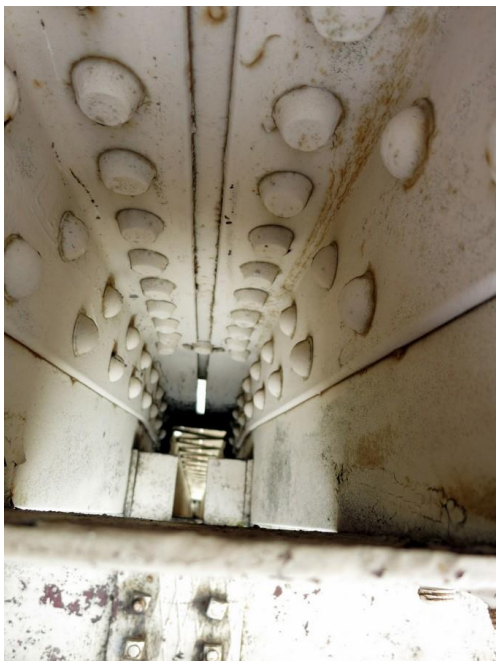
OBSERVATIONS	REFERENCE PHOTO
42. View looking down the inside of one of the Water Tower's legs.

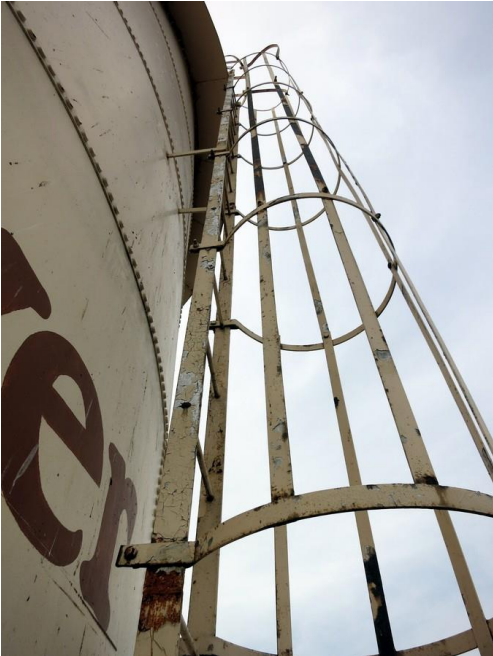
A close-up photograph of the side of a white-painted metal tank. The image shows a horizontal weld joint with several large, circular, raised rivets or bolts. The paint is slightly chipped and worn around the rivets, and there is some visible rust or staining along the weld line.
<p>45. A second ladder rises along the side of the tank. Like the ladder along the northwest leg, this ladder features surface rust and chipped paint, but is performing well and has a good connection to the Water Tower.</p>
