Agenda Item: Discuss Water Tower Issues

CONDITIONS ASSESSMENT FOR THE OSSEO WATER TOWER

415 CENTRAL AVENUE
OSSEO, MINNESOTA 55369

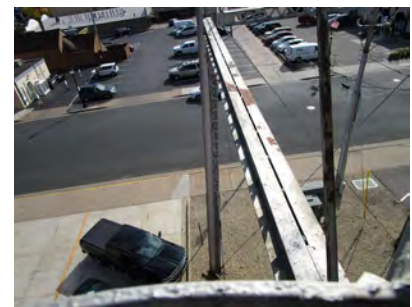
and horizontal members is chipping. The steel is corroding in the areas where it is exposed to the elements.

Peeling paint on structure, photograph facing south.

We recommend that all paint be removed, and the entire structure be repainted using the guidelines discussed in this report for the tank. Please see the recommendations about paint removal and recoating in that section.

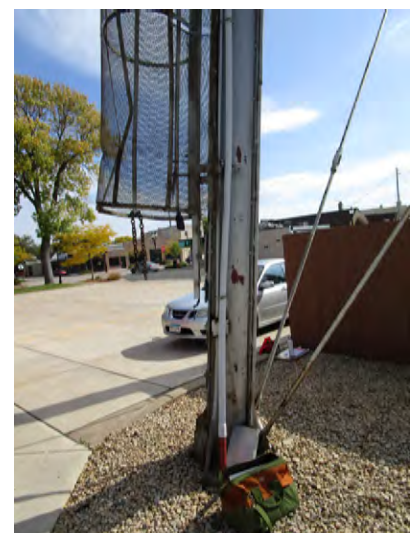
Bottom of ladder cage at northeast leg of tower.

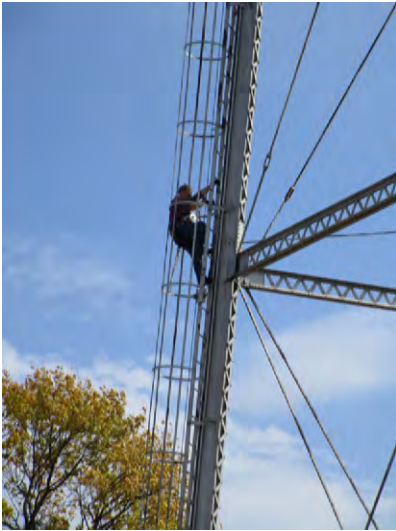
Ladder and cage at northeast leg of the tower.

The section of the ladder from the ground to the walkway has a ladder safety system consisting of a cable that runs the length of the ladder vertically. This system requires a harness with a front “D-ring” and a cable grabber. The cable grabber must be unpinned and repined at each cable support.

material be applied to the tops of the ladder rungs to increase traction and reduce the potential for falls during wind, rain, and other inclement weather.

If the ladder is to remain, this system is acceptable if the proper equipment is used. A harness with only a back “D-ring” should not be used, as the tie-off mechanism in this configuration would create a trip hazard. In addition, we recommend that an additional tie-off be used when the cable grabber is unpinned. At each cable support, a rebar hook should be tied to a ladder rung before the grabber is unpinned and removed after the grabber is in place and before the climber continues their ascent or descent.

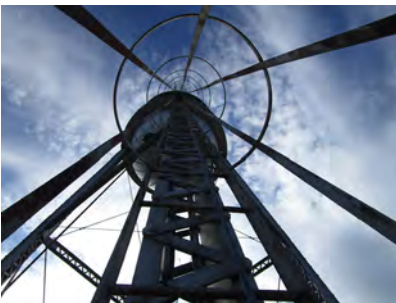
Photograph looking up from the inside of the ladder cage.

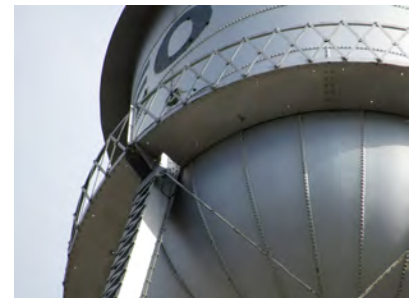
When stepping from the ladder onto the walkway, you must swing your legs over the existing railing. This is hard to do and unnecessarily dangerous.

Photograph showing balcony walkway cut out at leg and the guardrail.

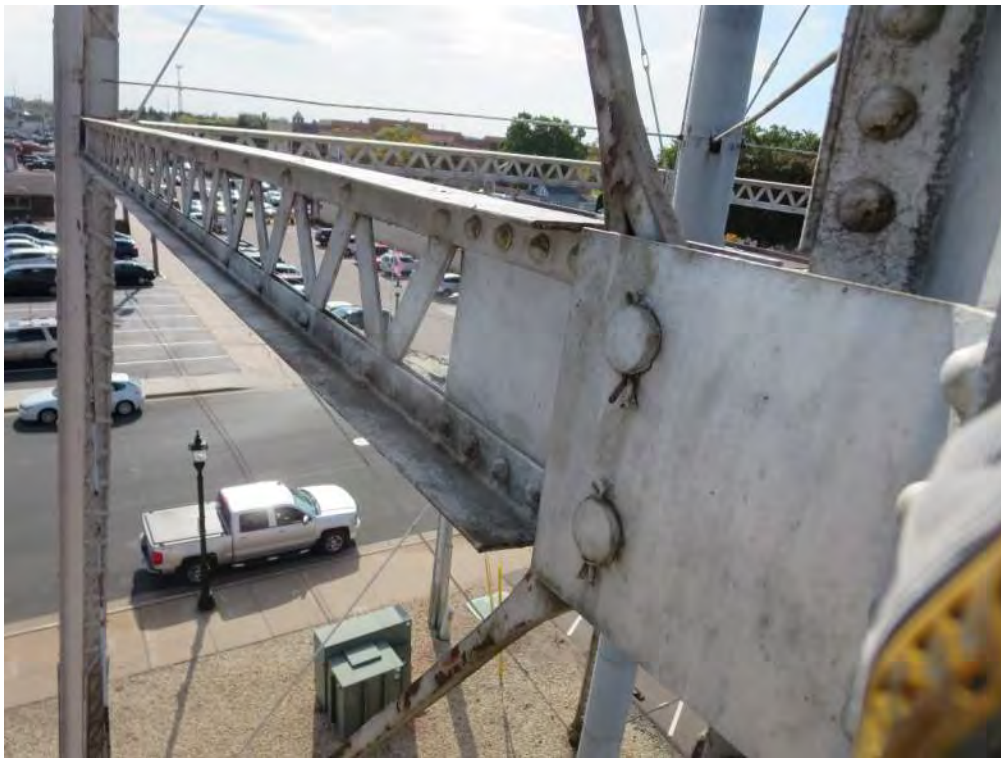
Photo 7 - Horizontal beam - note: cotter pins intact

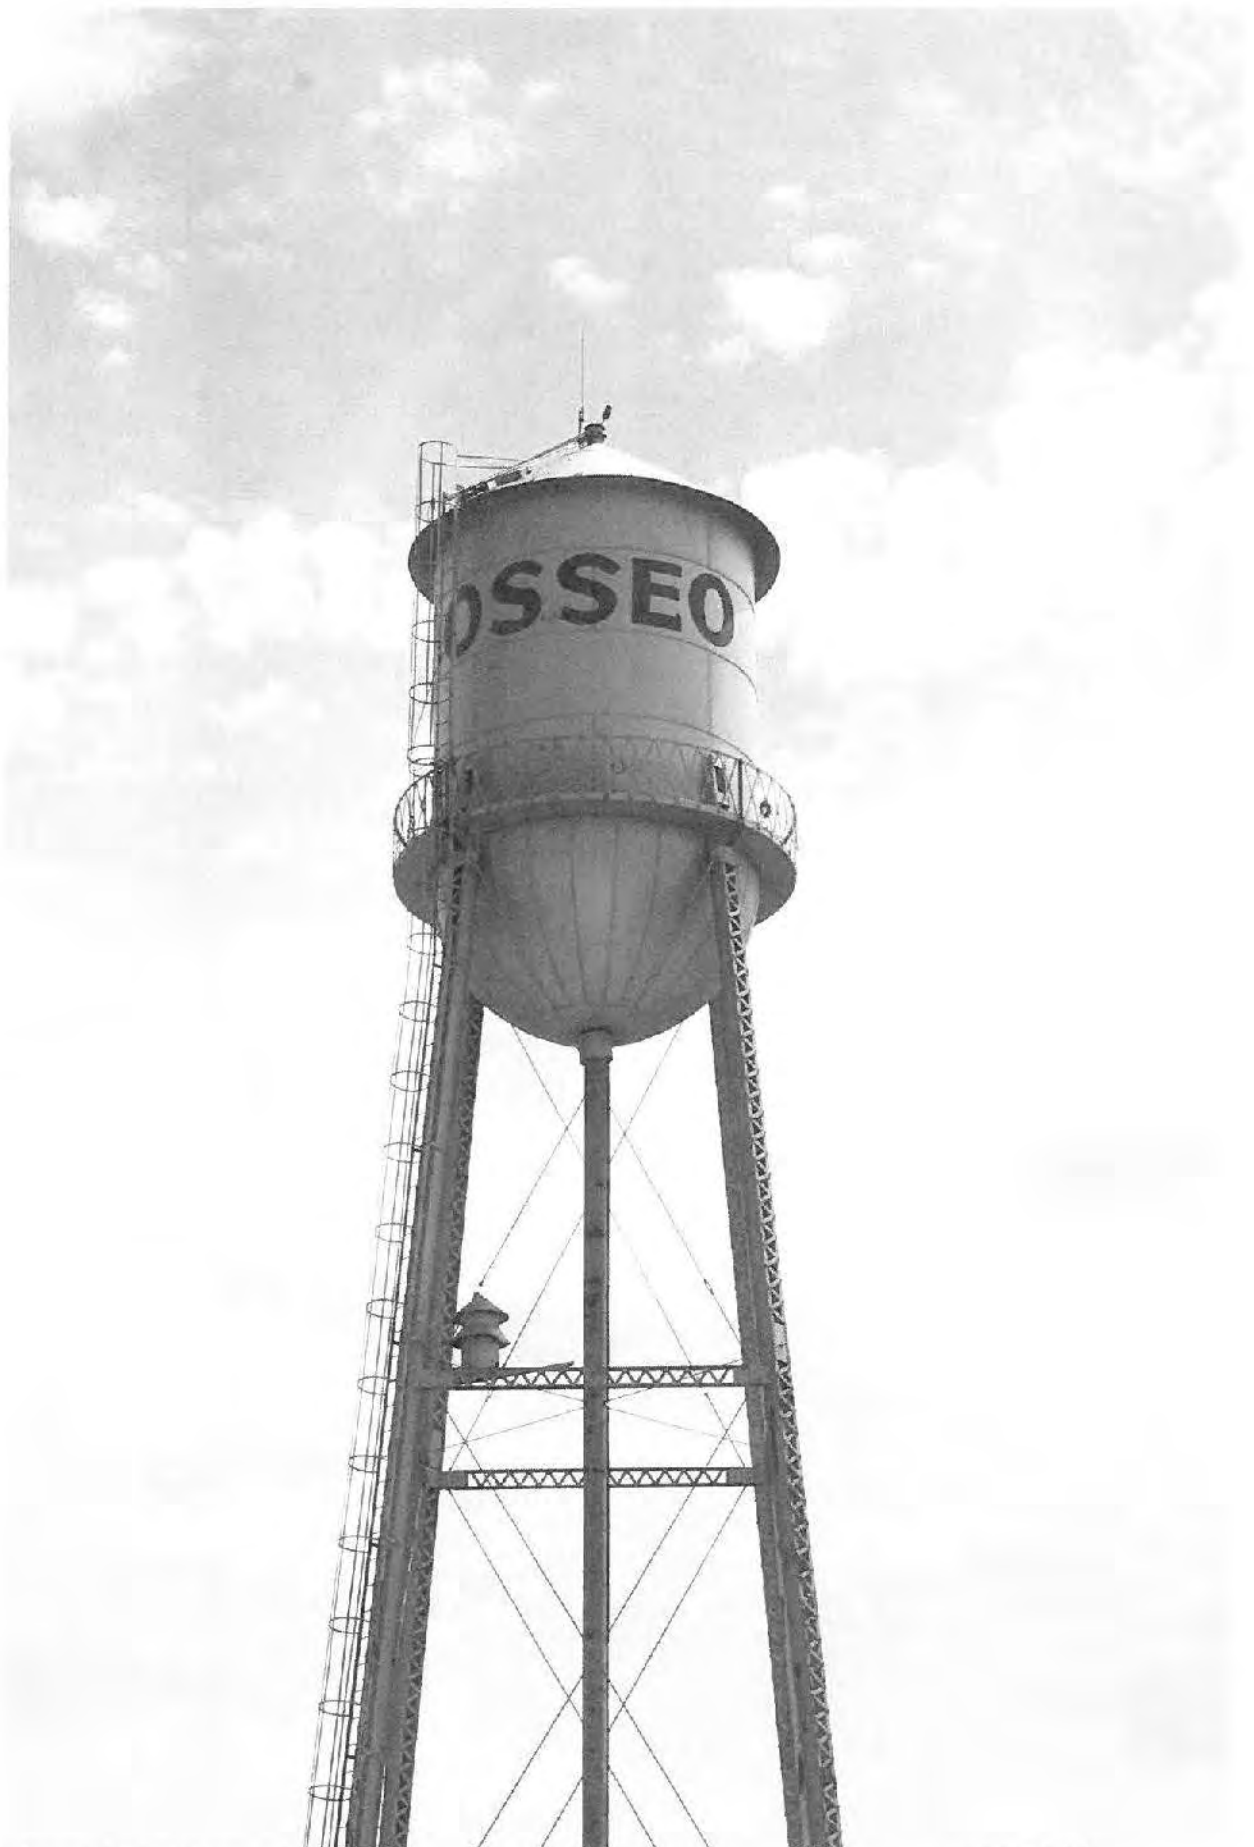
OsseoWaterTower_0010

View: View of the water tower base and pad, looking northeast
