Agenda Item: Discuss Water Tower Issues

CONDITIONS ASSESSMENT FOR THE OSSEO WATER TOWER

415 CENTRAL AVENUE
OSSEO, MINNESOTA 55369

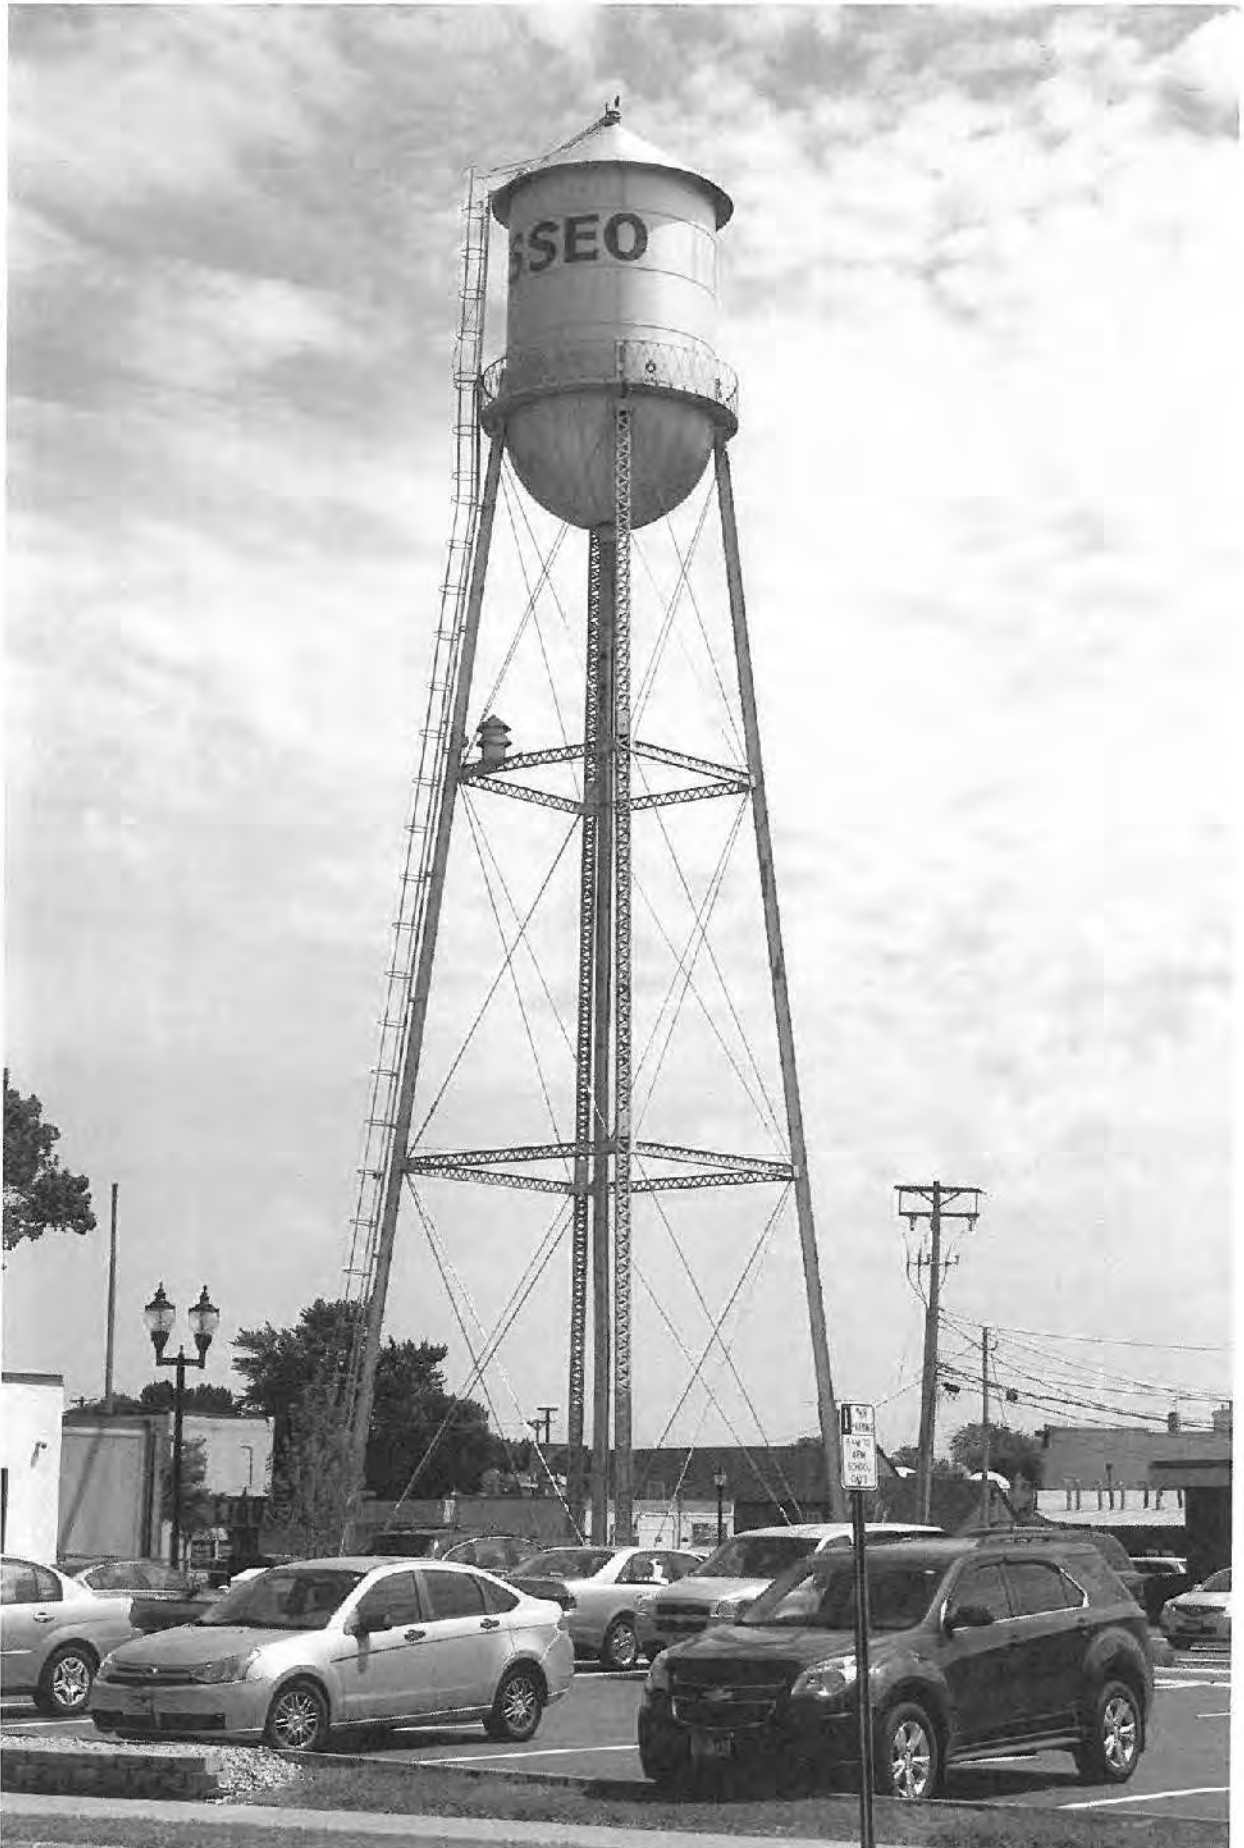
OsseoWaterTower_0007

View: View of the water tower looking northwest with the fire department at right

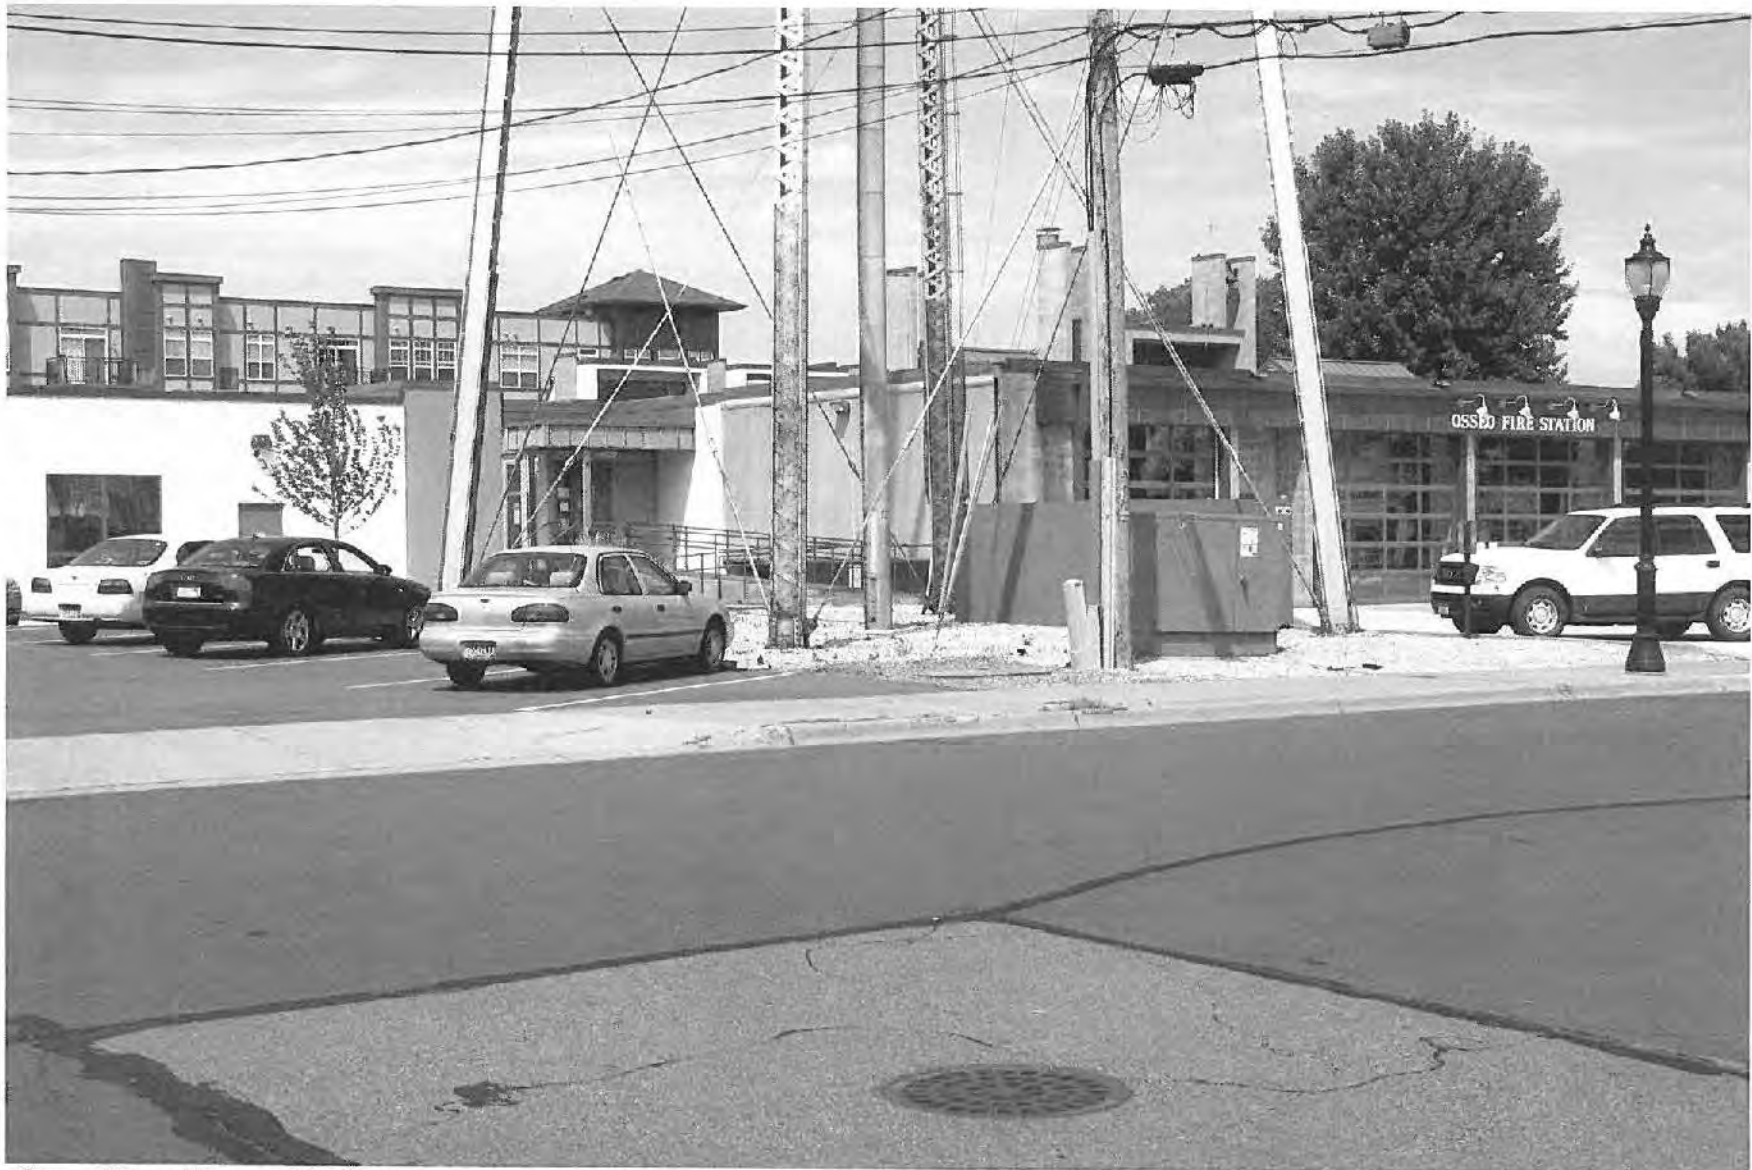
OsseoWaterTower_0009

View: View of the water tower looking northeast

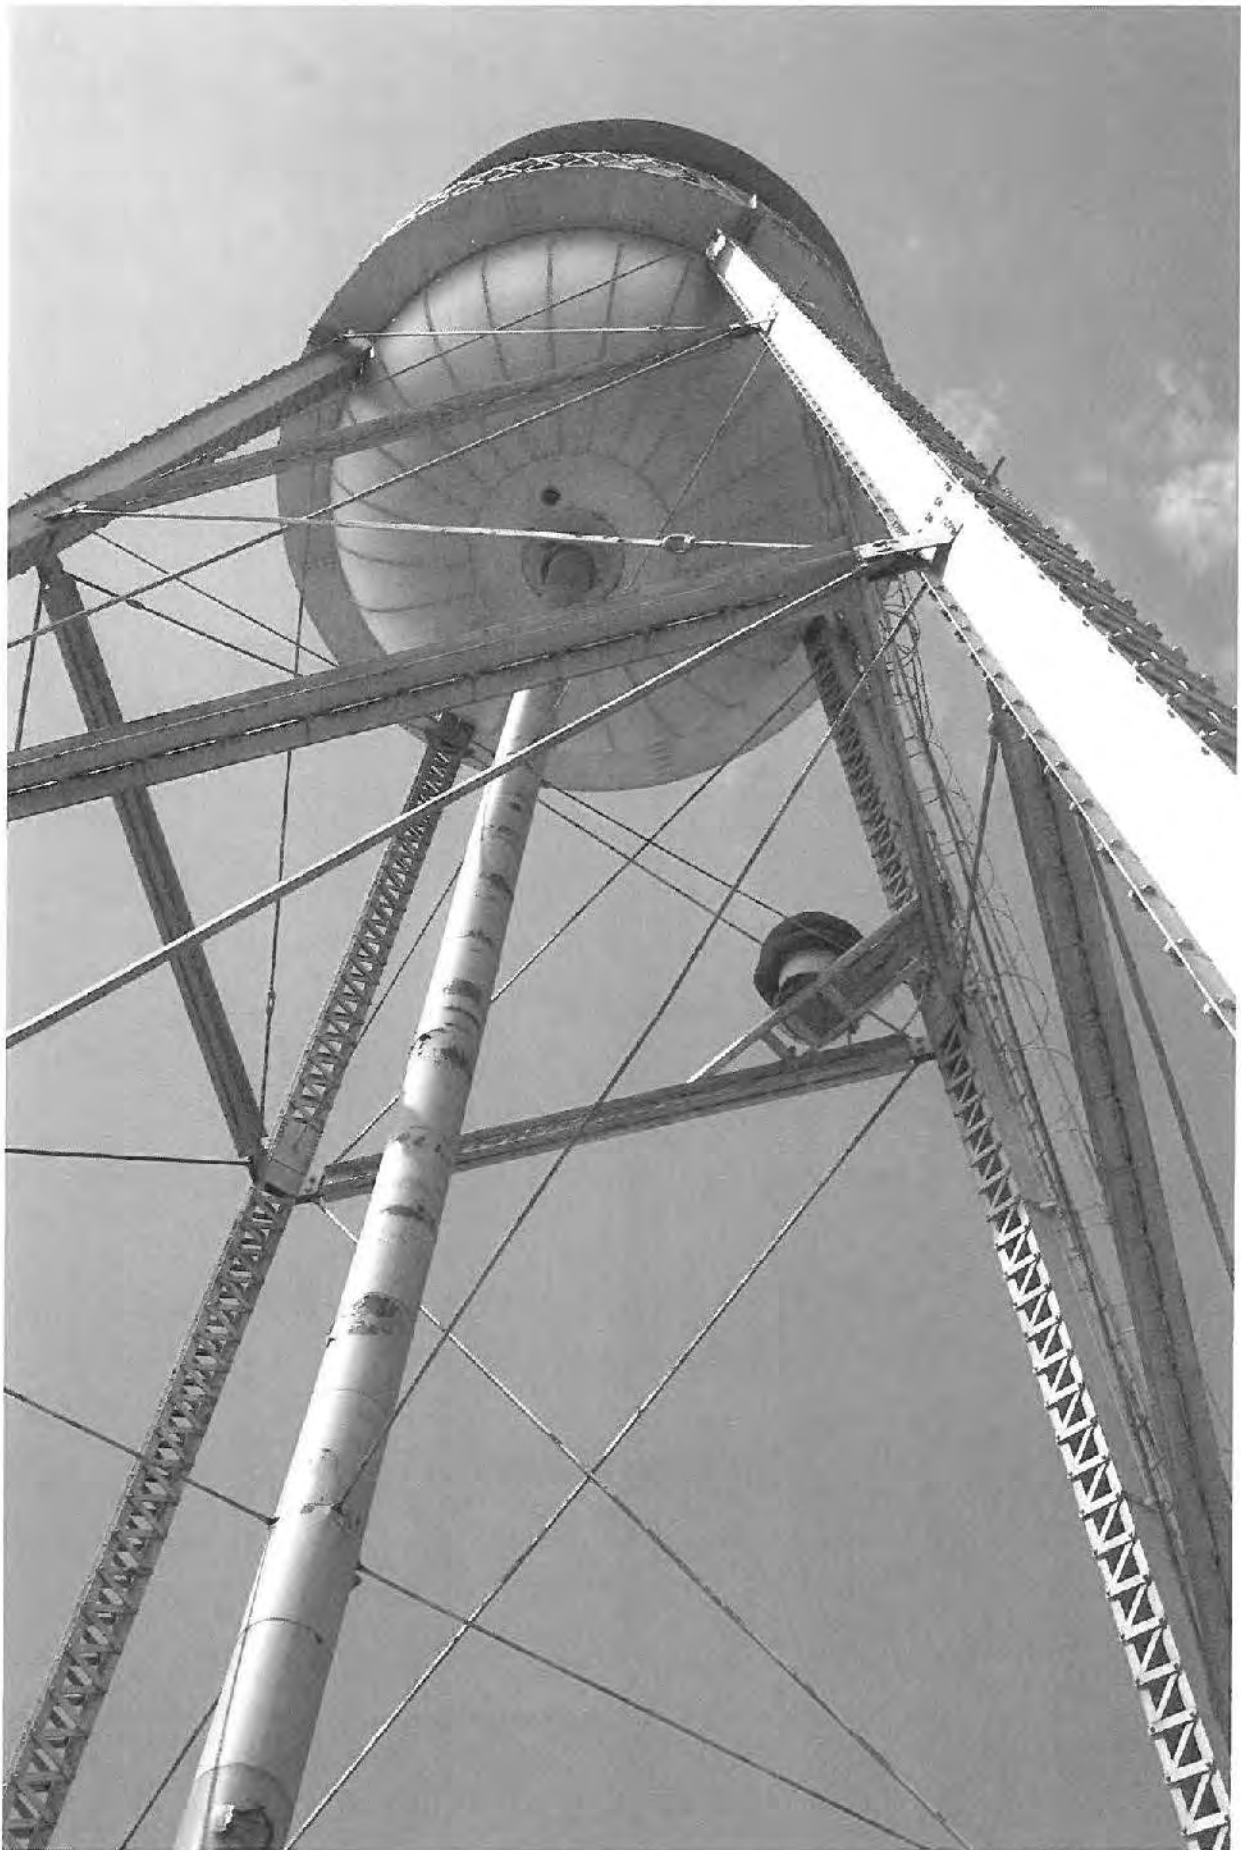
OsseoWaterTower_0011
View: View of the water tower's 50,000-gallon tank

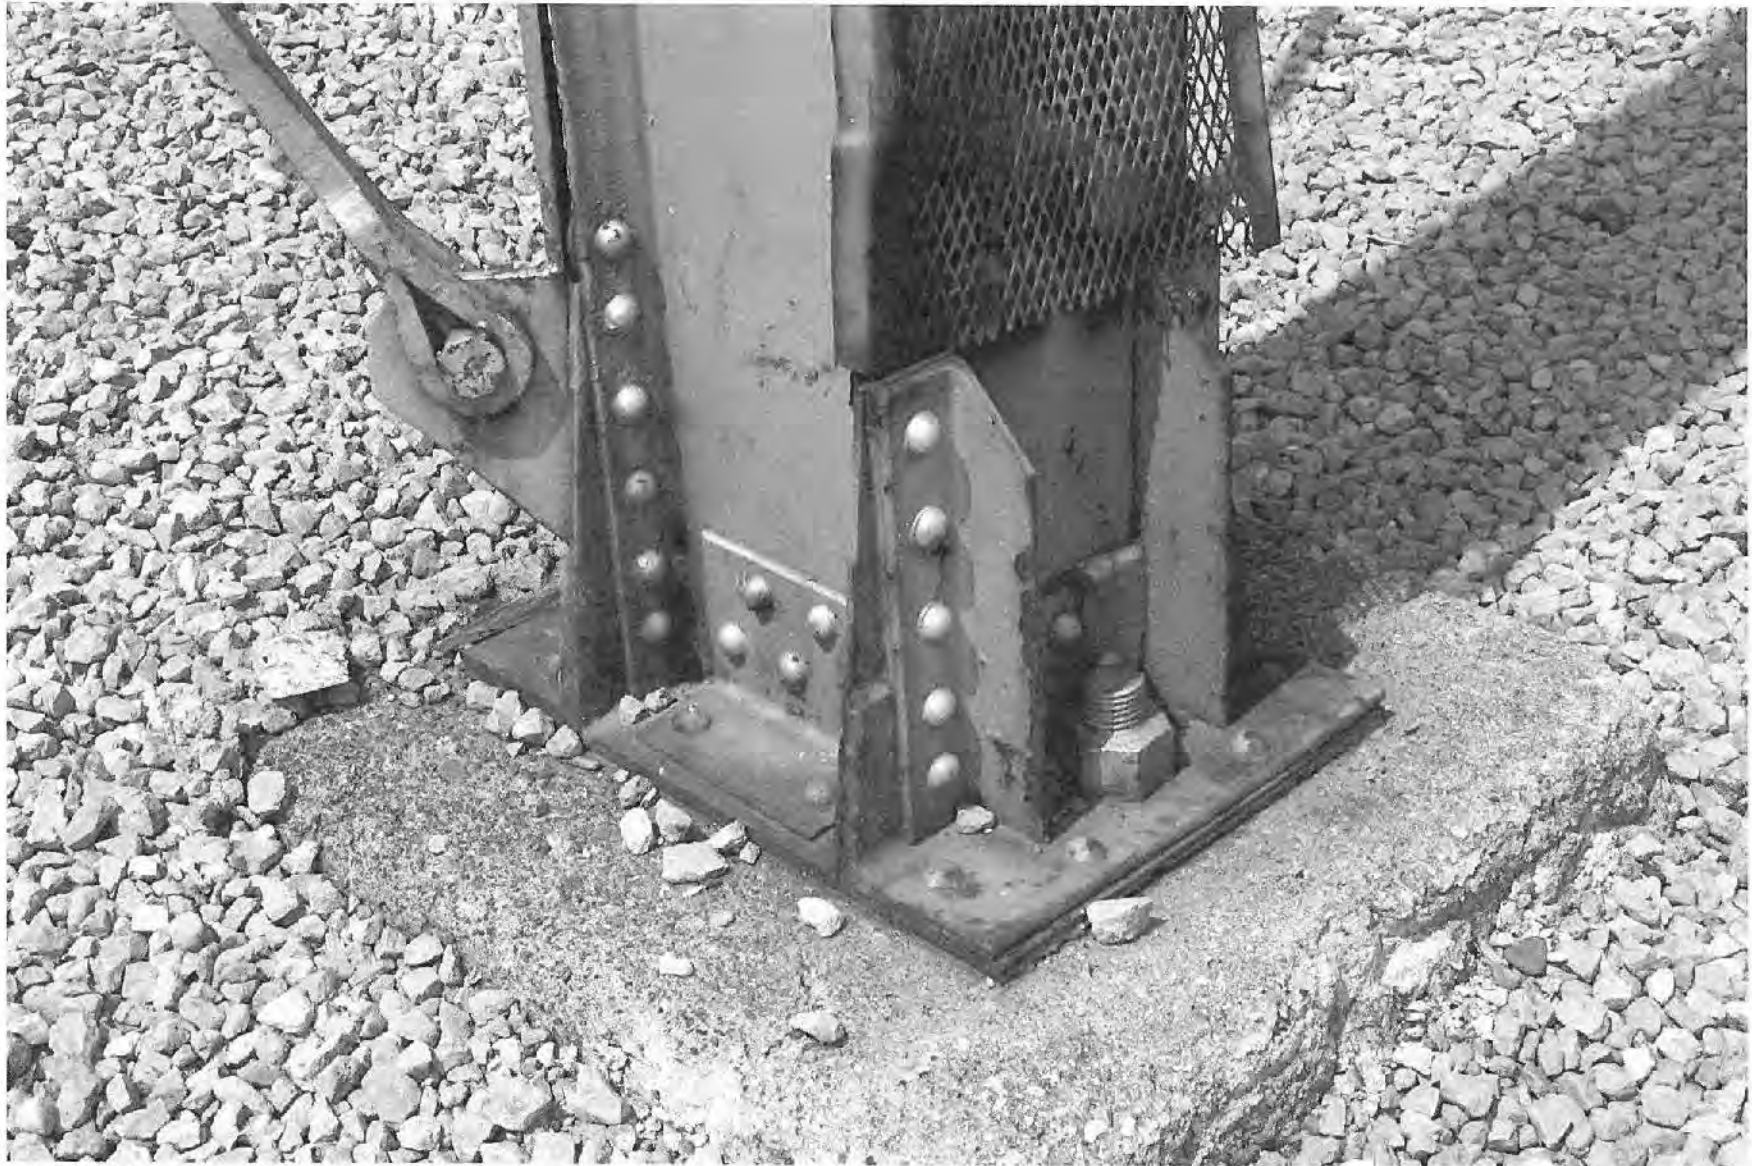
OsscoWaterLower_0013

Detail: View of the mounting of leg to concrete footing

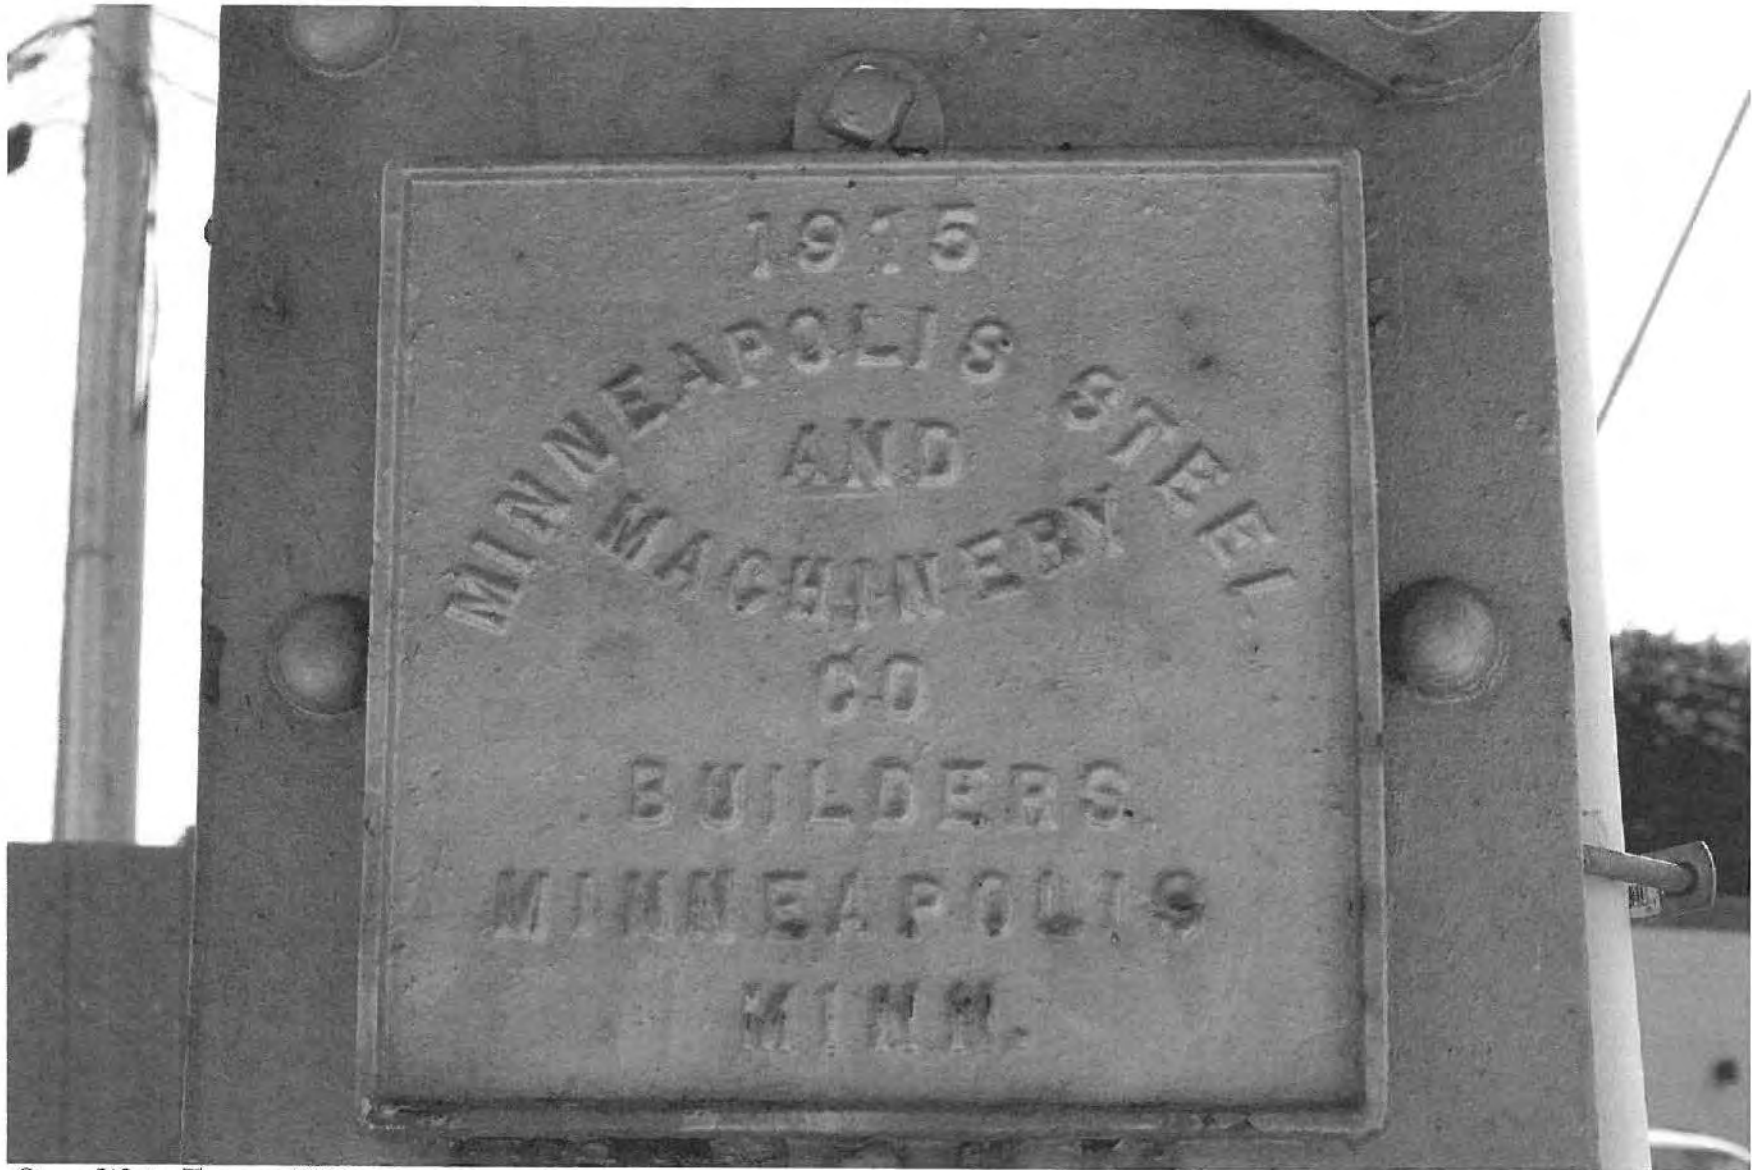
OsseoWaterTower_0014

Detail: View of the builder's plaque located on the NE leg
